HOW TO KEEP YOUR AWARD-WINNING BUILDING FROM ROTTING¹

Allen F. Rosenberg

W. Wayne Wilcox

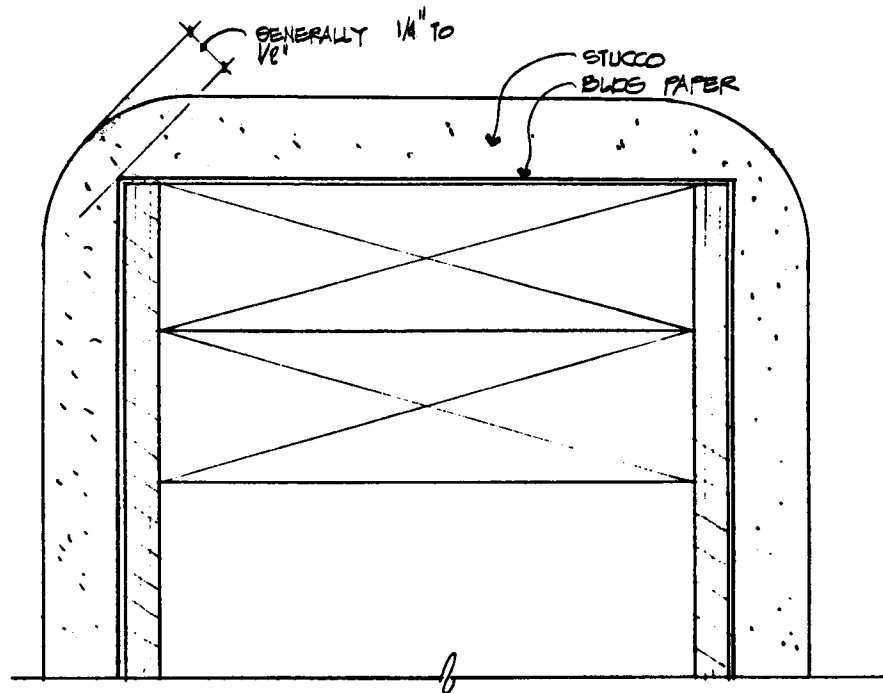
FIG. 4. Parapet cap as built leading to water infiltration when stucco cracked at corners.

The exterior stairways of the award-winning college buildings provide our first example. Figure 4 shows the parapet cap as designed. You will notice that the cement plaster was carried vertically up and over the top of the frame and down the other side. Although the detail shows a relatively uniform thickness of cement plaster, as it was actually built, the plaster was applied with no control over thickness. The plaster was mounded at the center of the top of the rail and tapered down to a very minute dimension at the corner, which invariably cracked. This

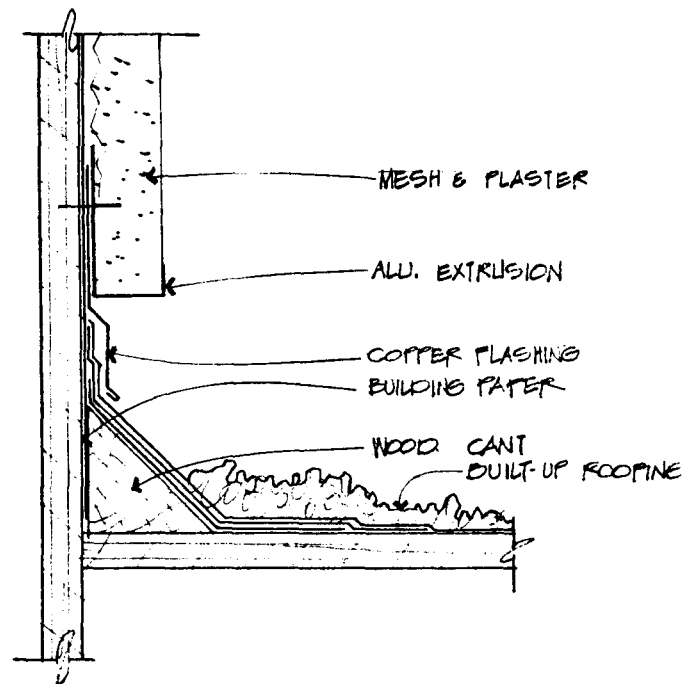
FIG. 6. Detail of vertical/horizontal intersection as built showing reverse shingling of building paper and flashing.

was installed in joints between vertical walls and horizontal roofs in reverse shingle fashion, thereby guaranteeing entry of water into the structure (Fig. 6). As corrected (Fig. 7) note that proper shingling of building paper and flashing was applied. A curious feature of the exterior stair detail of the college buildings is that the designer apparently knew it was going to leak, so sheet metal gutters were detailed underneath it (Fig. 8). As it was corrected (Fig. 9), a cap flashing was installed over the top of the stringer, and at the bottom side of the stringer a backer rod and a good grade of sealant were installed. Actually, the gutter system might not have contributed so greatly to decay if the joints had been soldered and if it had not terminated at the bottom into a $\frac{3}{8}$ -inch diameter copper tube. A tube of that dimension clogs up so quickly with dirt and debris that it ceases to function almost instantaneously. This clogging backed water up into the gutter, through the open joints and into the stud cavity, causing extensive decay of the wood frame.

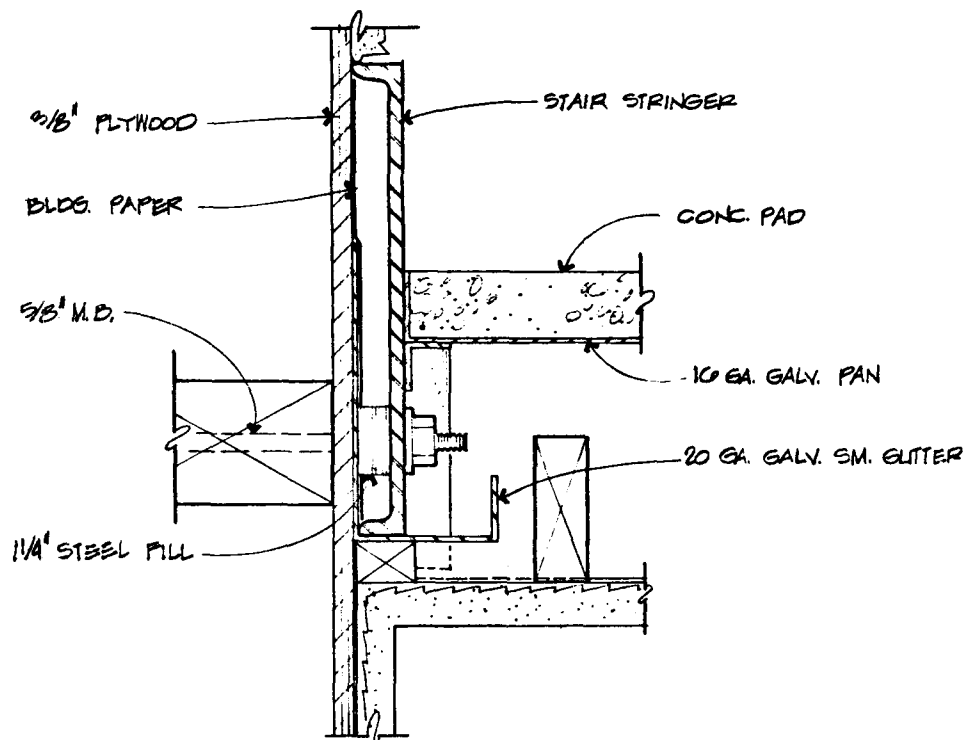
FIG. 8. Stair stringer detail as designed showing sheetmetal gutter.
