# SCANNING ELECTRON MICROSCOPY OF PLYWOOD GLUE LINES<sup>1</sup>

## ABSTRACT

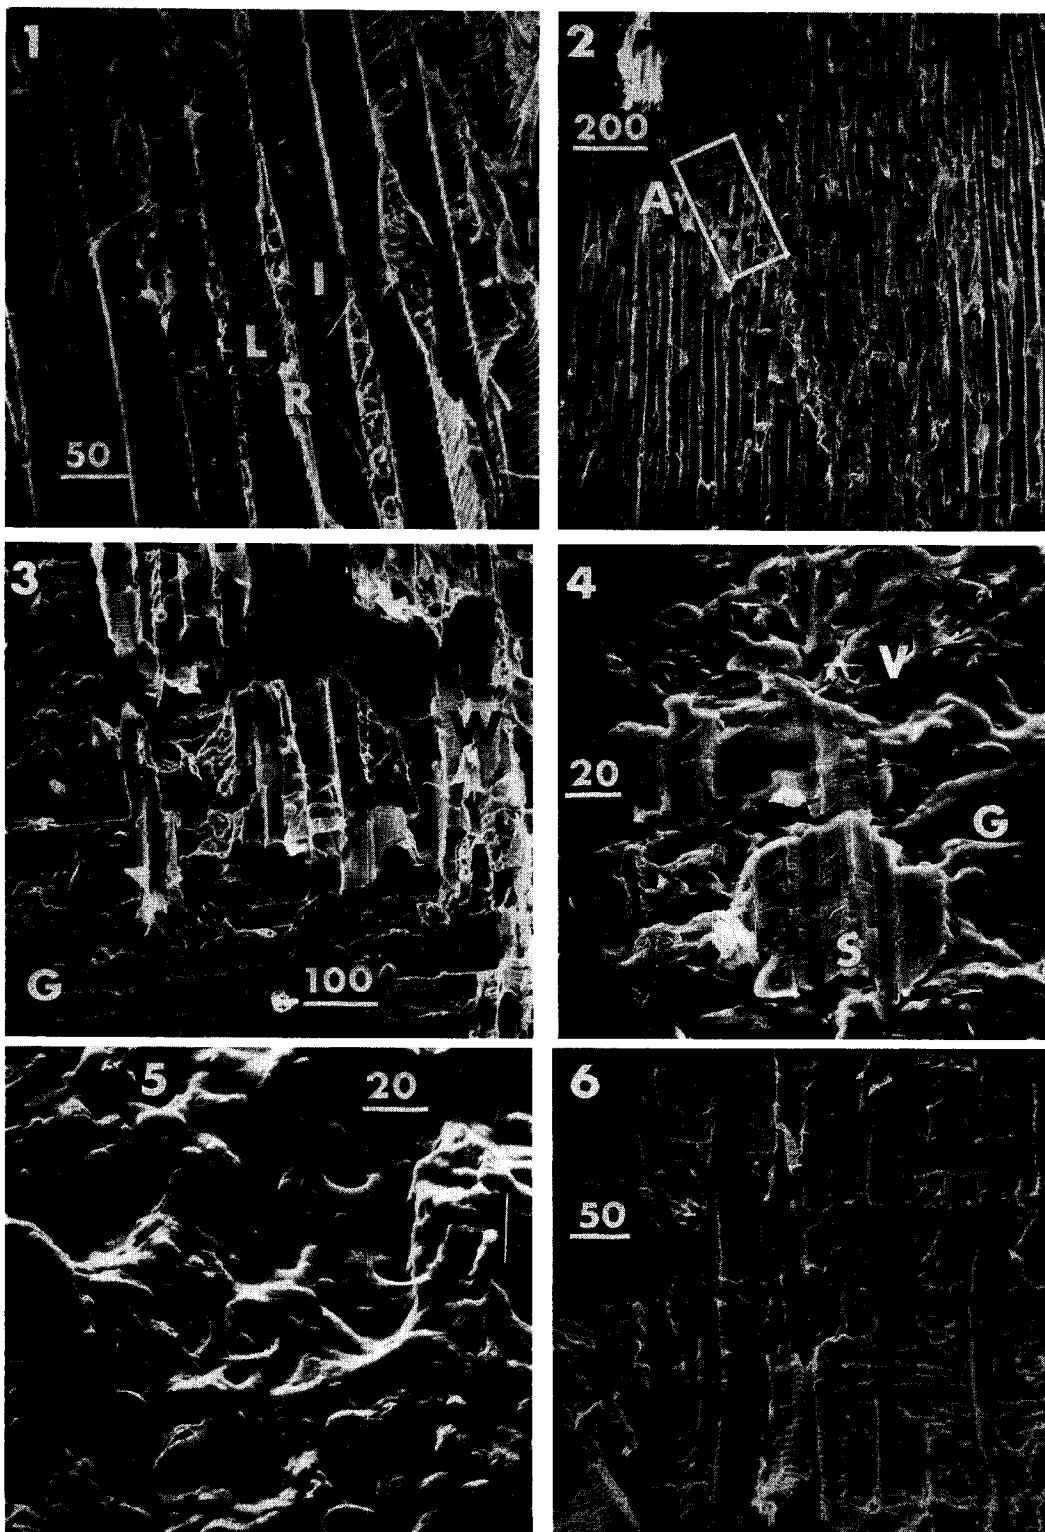
Figure 1 shows an example in which the tracheids on the veneer surface are split into two halves parallel to their long axes, thus exposing the fractured radial walls (*R*) and the inner surfaces of tracheids from the lumen side, that is the  $S_3$  layer of the secondary wall with the spiral thickening (*L*). In the fractured radial walls (*R*), all layers of the fiber wall are exposed. This type of wood failure is defined as "transwall failure parallel with the tracheid axis."

Figure 1 shows several examples in which the site of failure falls within the double tracheid wall (*I*), thus exposing its internal structure. This type of failure has been defined as "intrawall failure" (Koran 1968). In general, the areas exposed by transwall failure parallel with the tracheid axis and by intrawall failure are about equal. Transwall failure perpendic-

FIG. 1. Scanning electron micrograph (SEM) of Douglas fir plywood failure in the tangential plane showing transwall failure parallel with the tracheid axis, tracheids with spirals (L), and intrawall failure (I) indicated by tracheids without spirals. All scales are in micrometers ( $\mu\text{m}$ ).
