GROUND-PENETRATING RADAR INVESTIGATION OF SALVAGED TIMBER GIRDERS FROM BRIDGES ALONG ROUTE 66 IN CALIFORNIA¹

Abstract. This study describes assessment of the internal conditions of timber bridge structural members along Route 66 in California. These timber bridges were exposed to desert climate conditions for several decades, which can lead to a variety of deterioration. Overtime, the deterioration may cause loss of structural integrity within the bridges and lead to potentially hazardous conditions for the motoring public. Members from dismantled bridges were brought to the Forest Products laboratory in Madison, WI. Strength-reducing features including decay, splits and cracks, insect attack, and corrosion of metal components were initially identified using visual inspection. Further assessment was then performed using several nondestructive testing technologies including ground-penetrating radar (GPR). GPR was used, among other nondestructive techniques, to identify and locate internal features and defects within the timbers. The tomographic output of the GPR, known as radargrams, revealed deterioration. Based on the information contained within the radargrams, it was possible t

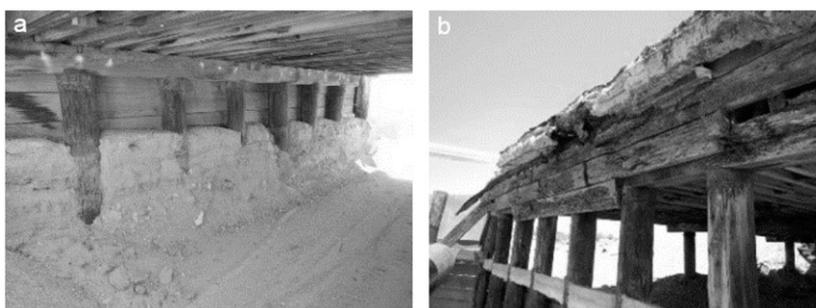
Figure 2. Bridge defects by visual inspection that include flood scouring: (a) annual floods deposited silt and (b) erosion around bridge abutments.

Overtime, exposure to the environment has caused damage to the bridge and led to potential safety risks. Annual floods deposited silt (Fig 2[a]) under bridges and, in some cases, eroded bridge abutments (Fig 2[b]). The erosion also caused decay on the abutment back walls. Common methods of protecting and reinforcing the abutment include seasonal removal of silt, abutment wing wall repairs (Fig 3[a]), and adding temporary midspan shoring (Fig 3[b]). Damaged stringers were reinforced by attaching metal bars under the stringers. For the nail-laminated decks, repairs and regular evaluations of intermediate pier supports are also important (Fig 4[a] and [b]).

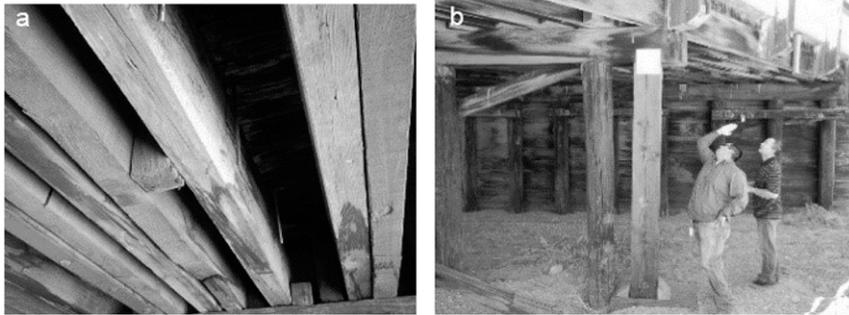
Figure 4. Bridge evaluation: (a) reinforcement of damage stringers and (b) evaluation of intermediate pier pillars.

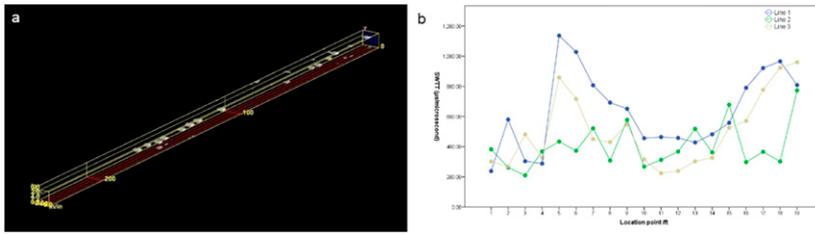
RADAN software allows abutting 2D images to be assembled into a 3D image. The 3D image gives additional information regarding the size and location of defects. The compiled 3D image is shown in Fig 14(a); the yellow lines show the outline of the timber, and the bright areas are the interior metal. As mentioned in the description of Fig 8, the sides of the timbers were scanned along three lines using both GPR and acoustic stress wave inspection. The

results of the acoustic inspection are shown in Fig 14(b). Higher microsecond travel times from 1.23 m to 2.13 m and 4.57 m to 5.80 m are seen in areas of metal connectors as identified by the 3D

Figure 14. 3D and acoustic results of No. 5: (a) 3D image of No. 5 and (b) the results of acoustic tests.

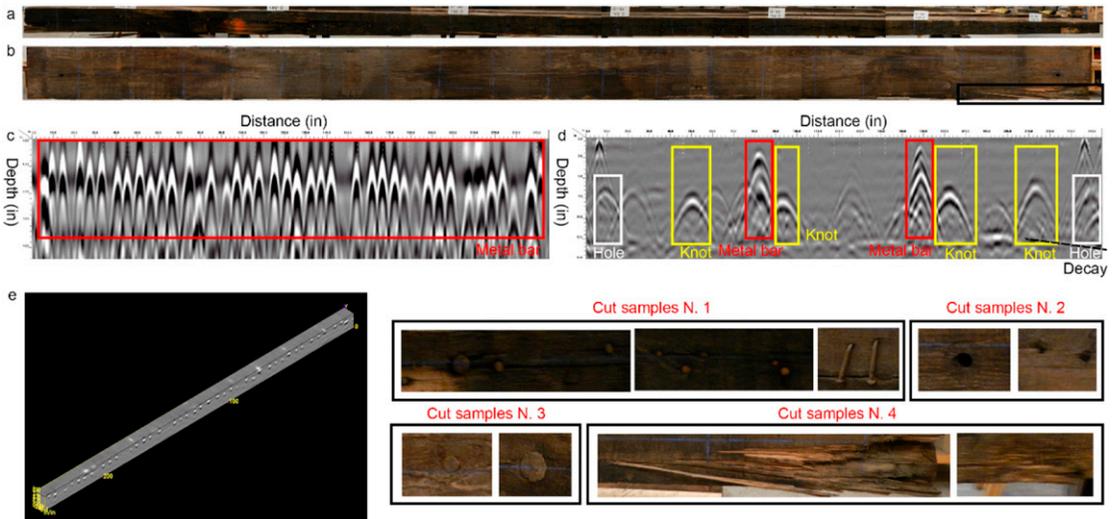
Figure 15. Comparison of No. 18 timber with radargram and camera pictures.

Timber 18 had many defects: four cracks, 23 knots, 7 holes, and 105 metal nails and bars. Figure 15(a) and (b) show Faces D and E. Surface defects were identified from the images. Metal connectors were used along the length Face D of the timber. The connectors were driven perpendicular to Face D and parallel to Face E. Scans of Face E show high numbers of metal connectors; the connectors are identified by red boxes in Fig 15(c). The white dots in the 3D image shown in Fig 15(e) correspond to the locations of the metal connectors. The nails are shown in cut sample No. 1. Several bars were used to assemble the bridge. The Face D scan revealed two large bars

indicated by red boxes in Fig 15(d). During disassembly, many of these bars were removed leaving holes; these holes are shown in Fig 15(d) within the white boxes. Large knots are also visible and are identified with yellow boxes. A close-up view of the knots is shown in cut sample No. 3. The black box in Fig 15(b) and the black line in Fig 15(d) indicate a region of decayed and broken wood. A larger view of the decayed region is shown in cut sample No. 4. Reflections caused by metal are noticeably brighter than reflections caused by other features. Smaller diameter nails produce less noticeable reflections than larger diameter nails. In some cases, closely spaced metal connectors appear as a single feature in the radargram.
