# TECHNICAL NOTE: LIGHT FRAME WOOD TRUSS ROOF COLLAPSE IN MISSISSIPPI, A CASE STUDY

**Abstract.** In or around 1972, an experimental building was constructed. One of the intents of the construction project was to demonstrate advancements in wood building construction design. It was value-engineered throughout. That is, its materials and systems were intended to function at or near design capacity. In 2019, part of the roof of the structure collapsed. This case study investigates two potential factors that led to the failure: stress concentration in excess of the allowable stress for  $2 \times 4$  web members and insufficient plywood sheathing to support live loads caused by large rain events.

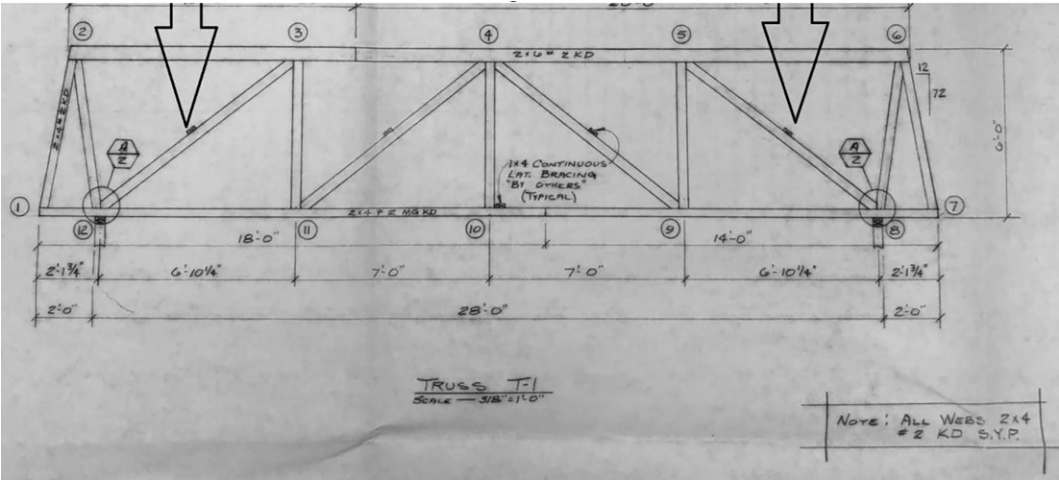
who reported periodically hearing “wood snapping” and “wood cracking” above their heads, inside and above the suspended ceiling. Inspection of the roof framing revealed that, the web members who failed were the ones who ran upward, diagonally, from the exterior southeast wall toward top chord, toward the interior of the building. The failure was due to columnar buckling in nonbraced compression web members. Figure 1 illustrates the web critical web member on the original truss blueprint. Neither decay nor overloading seemed to be factors in the failure.

Figure 1. Original truss blueprint with the critical web member(s) denoted.

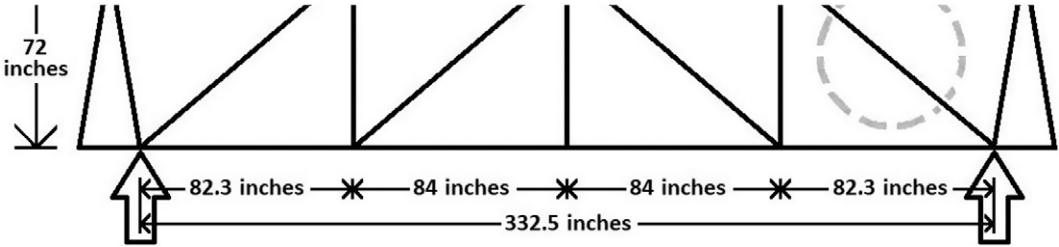
Figure 2. Truss diagram. The support reactions are shown at the centerline of the exterior support walls. The dotted circle indicates the web member who failed on multiple trusses and appears to have initiated the collapse.

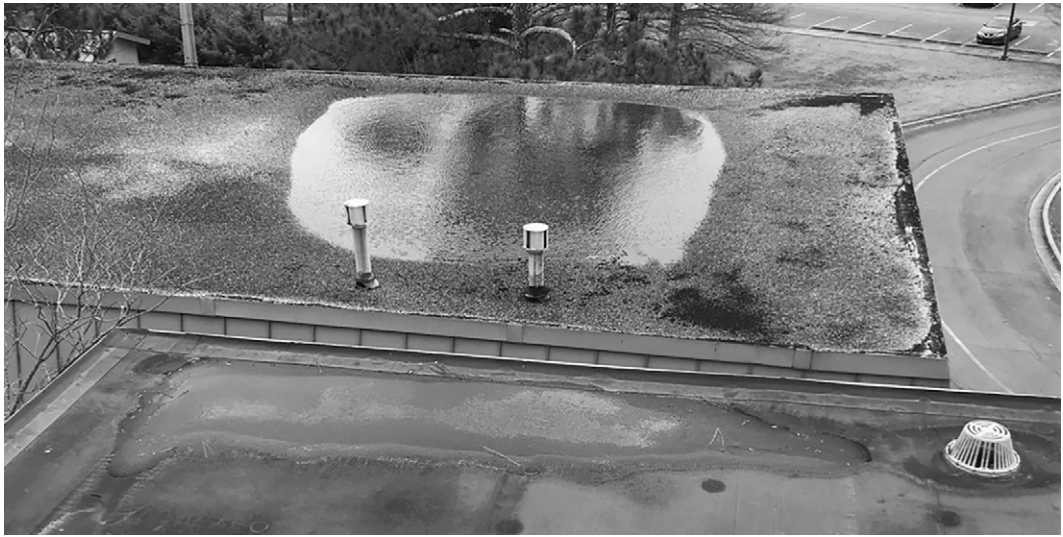
immediately inspected. The suspended ceiling tile system had come down as much as 12.25 cm (6 inches) under some of the trusses in the area of failure. Inspection of the roof truss system, by ladder from inside the building, indicated that several trusses were failing. Ultimately, these failures should likely be classified as deflection induced, that is, long and unbraced columns deflecting, which led to ponding, which exacerbated the deflection, and so on up until catastrophic failure. Common to these failures were the unbraced compression web members immediately atop the south-east wall (similar to the web members who broke and were repaired, in another area of the building, approximately 15 yr prior). Inspection of the roof showed ponding, that is, additional dead weight on the system. The pond's maximum depth was estimated at 7.5-10 cm (3-4 inches) and its area

was estimated at approximately 6.7 × 6.7 m (22 × 22 feet) (Fig 2). At that stage, it appeared that catastrophic roof failure was likely imminent and there would not be time to propose and/or enact a repair. As such, the area at issue under the roof was blocked off to avoid any potential injury. That evening, during a heavy rain and wind event, approximately 8 h after the initial reports of “wood breaking” were received, the roof collapsed (Fig 3).

Figure 3. Ponding on roof, over an estimated  $6.7 \times 6.7$  m ( $22 \times 22$  foot) area, hours before a heavy rain and windstorm event during which the roof collapsed.

It is estimated that the dead load of the roof system is at least 0.67 kPa (14 psf). Combined with a 0.96 kPa (20 psf) live load (by design), the total design load for the structure is 1.63 kPa (34 psf). It is noted that a 7.6-cm (3-inch) deep pond equates to approximately 0.77 kPa (16 psf) live load—in perpetuity. As such, it seems reasonable to assume that, at least in some portion of the roof's area, it experienced this loading more or less in perpetuity. In contemporary allowable stress design, it is anticipated that members and or structures will only experience full design load for 10 yr, cumulatively, throughout the life of the structure. Permanent or perpetual loading requires an adjustment factor of 0.9 to bending strength.

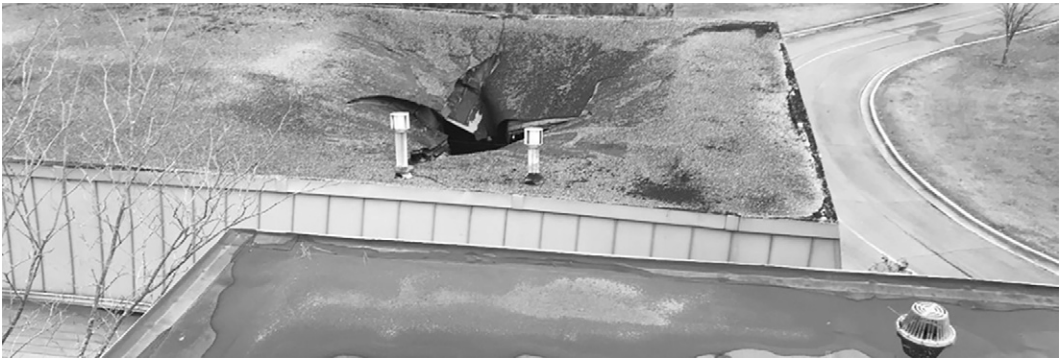
Postcollapse inspection of the remainder of the building's noncollapsed roof framing, revealed significant compression-induced deflection in the web member of interest. Figure 4 illustrates a series of trusses with their unbraced web members as they sit atop the exterior wall. An exemplar web member (Fig 5) was photographed in an effort to measure the deflection against a stringline. At the time of the photograph in Fig 4, there was no standing water on the roof. Thus the only loading on that truss at that time is the approximate 0.67 kPa (14 psf) dead load. At 1.63 kPa (34 psf) combined load, 9.22 m (30.25 foot) top chord length, and 1.22-m (4-foot) spacing, each truss is intended to carry 1866 kg (4114 pounds). That level equates

Figure 4. Roof section, approximately  $7.3 \times 8.5$  m ( $24 \times 28$  feet), (7 trusses each 28-feet long) immediately following collapse.

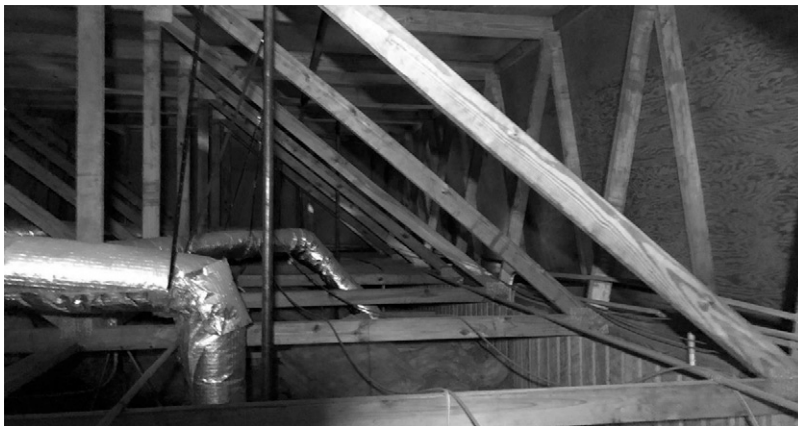
Figure 5. Series of repetitive flat roof trusses sitting on the exterior roof wall. Of particular interest is the unbraced  $2 \times 4$  compression web member running diagonally up from the exterior wall.

As built however the columns (compression web members of these trusses) are entirely unbraced. Thus, their slenderness ratio (67.3) exceeds that allowable per guidance of that period (50), per the Southern Pine Manual of Standard Wood Construction (1975). By calculation, the  $F_c$  for these web members in service approximately 620 kPa (90 psi). As the actual columnar stress on each of these web members appears to be on the order of 3185 kPa (462 psi). As such, in service, these web members appear to be overloaded by a factor of approximately 5.

As designed, and as constructed, the web member of interest behaves as a long column. In this type of situation, its allowable columnar stress is limited by its modulus of elasticity. The truss design calls for a (nonstructural) "1 × 4 continuous lateral bracing by others (typical)" such that each column (compression web member) would be braced to the analogous members in the trusses immediately adjacent thereto. If that bracing had been installed, and if it had acted in some type of structural capacity, in the best-case scenario, the web member of interest's slenderness ratio could have been

reduced to approximately 33.7. In that case, the bracing may have raised the allowable design capacity, corrected for duration of load, to approximately 2468 kPa (358 psi). In all likelihood, this action would have prevented and mitigated the long-term deflection and avoided the premature catastrophic failure.

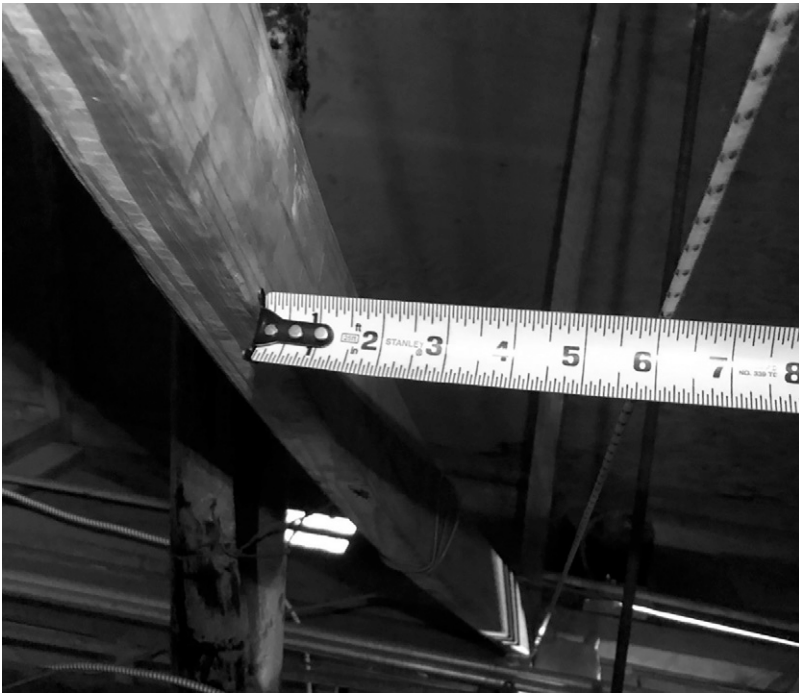
Figure 6. Exemplar web member showing 15.5 cm (6-1/8 inches) of deflection. The member is  $2 \times 4$ , #2 as called for in the truss diagram. Its unbraced length is 256.5 cm (101 inches). The truss had little or no live loading at the time of the photograph.

Thus, the estimated bending stress ( $s$ ), absent any creep, to create the level deflection as observed is 4,469<sup>2</sup> kPa (6482 psi) in a series of compression web members whose  $F_b$  values is 9308 kPa (1350 psi) (Southern Pine Manual of Standard Wood Construction 1975).

The excessive deflection in this web member of interest facilitates significant sagging in the top chord and thereby permits excessive ponding. This ponding, and its associated perpetual loading likely contributed to the collapse. At the time of the inspection, many of the roof trusses that remain in service in the building appear significantly overloaded. Based on this finding, it will be recommended that the roof system be completely redesigned and rebuilt prior to reoccupancy or that the structure be razed and rebuilt depending on the associated costs of each alternative.

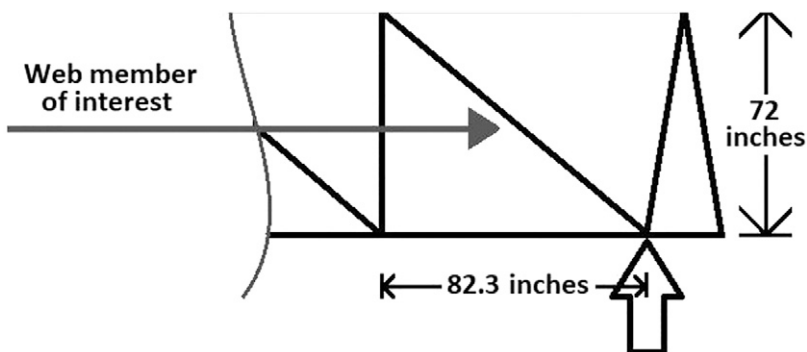
246.75 kg (544 pounds) (1.22 lineal meters [4 lineal feet] times 202.4 kg per lineal meter [136 pounds per lineal foot]). The balance of the reaction force ( $933 \text{ kg} - 247 \text{ kg} = 686 \text{ kg}$  [2057 pounds - 544 pounds = 1513 pounds]) is transferred vertically through the web member of interest. Figure 7 illustrates this post-collapse analysis.

Figure 7. Determination of reaction force transferred to the web member of interest. The total vertical reaction is estimated as 933 kg (2057 pounds). The load from the outer 1.22 lineal meters (4 lineal feet) (246.75 kg or 544 pounds) of the top chord is transferred to the support wall by the outer compression web member. The balance, 686.3 kg (1513 pounds) is the vertical reaction force that the web member of interest resists.
