# FIRE SAFETY OF MASS TIMBER BUILDINGS WITH CLT IN USA

## David Barber\*

**Abstract.** Multistory buildings using mass timber and cross-laminated timber (CLT) as the primary structural elements are being planned and constructed globally, with interest starting to gather momentum in the United States. Model building codes in the United States limit timber construction to a building height of 85 ft (25.9 m) because of concerns over fire safety and structural performance. Up to 85 ft, the mass timber can be exposed. Architects and developers in the United States are pushing boundaries, requesting mass timber structures are constructed as high-rises and that load-bearing mass timber such as CLT be exposed and not fully protected. This provides an opportunity for the application of recent fire research and fire testing on exposed CLT to be applied, and existing methods of analyzing the impact of fire on engineered timber structures to be developed further. Fire testing has shown that exposing large areas of CLT significantly impacts the heat release rate and fire duration. This article provides an overview of the code requirements for timber construction in the United States, provides

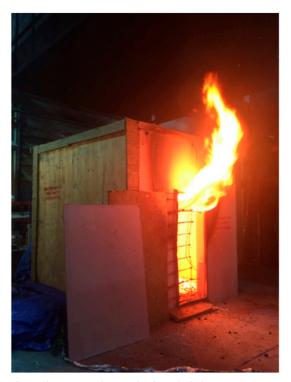
Figure 2. Exposed cross-laminated timber compartment fire test undertaken at BRE by the University of Edinburgh and Arup (image, Arup).

There has been a number of full-size fire tests of rooms with exposed CLT panels (walls or underside of floor) in Canada, Europe, UK (see Fig 2), Australia, and United States (Frangi et al 2008; Wilinder 2010; Craft et al 2011; Aguanno 2013; McGregor 2013; Medina 2014; Hox et al 2015; Kimball et al 2017; Emberley et al 2017; Hadden et al 2017). The aim of the fire testing has been to understand how exposed timber influences fire size and duration and to also understand the effectiveness of CLT protection systems. Small-scale tests by Crielaard have also been informative (Crielaard 2015).

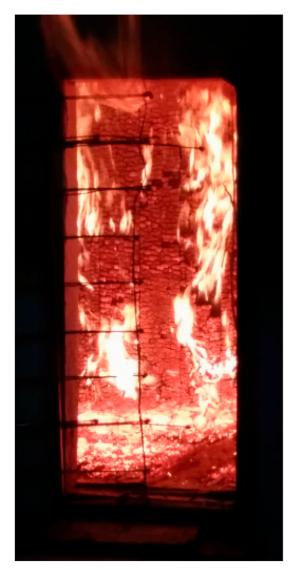
Figure 3. Cross-laminated timber with delamination occurring at ply interface (dark areas on wall) during fire test (image, Arup).

char occurs because of the ply adhesive softening under increased temperatures (see Fig 3).

Delamination is an important issue for exposed CLT, because if the char that protects the unburnt timber falls off, unburnt timber is progressively exposed to the fire. This results in an increased burning rate at the freshly exposed timber, until a new layer of char has formed. When delamination in the CLT occurs, it can result in a higher HRR and more CLT being consumed by the fire. Delamination is typically represented in compartment fires by regrowth of the HRR as the ply interface is reached (Frangi et al 2008; McGregor 2013; Medina 2014; Klippel et al 2016). CLT panels located horizontally (underside of floors) are more susceptible to delamination than panels located vertically (walls). The extent of delamination varies between panel manufacturers, given each manufacturer uses different timber species (density), timber size, gluing patterns, and importantly, type of adhesive. Delamination is accounted for within the methodology to calculate char rate in panels within the CLT Handbook (Karacabeyli and Douglas 2013).
