EFFECT OF WOOD DENSITY AND CRACKS ON THE MOISTURE CONTENT OF COATED NORWAY SPRUCE (*PICEA ABIES* (L.) KARST.)

Abstract. A protective coating is often used on the cladding of wooden facades to limit the absorption of moisture. Low wood moisture content (MC) is essential to obtain satisfactory durability performance. Wood density is known to influence the water sorption and crack formation of uncoated wood. However, the effect of density on the aforementioned behaviors of coated spruce is not yet fully understood. Six-years of data on the crack formation and the MC variation of outdoor exposed panels are analyzed in this article. The outdoor test was complemented by a subsequent laboratory experiment, wherein the MC variation was monitored at different depths on the board during artificial water spraying. The aim of this research was to increase the knowledge about how wood density and aging affect the water sorption of coated spruce through the crack formation. The results indicated that wood density had an impact on the overall sorption behavior of coated spruce. Low-density spruce contributed to faster water absorption and desorption processes than coated samples with higher dens

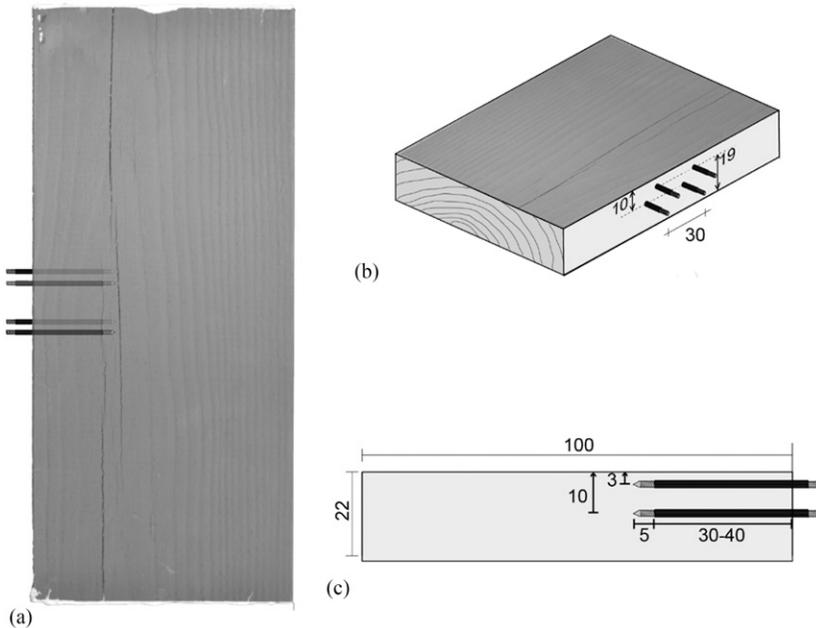
Figure 1. The electrode configuration on a weathered replicate with a larger crack. Top view (a), perspective view (b), and cross section (c). Units in (mm).

The electrodes were installed at two different depths, as shown in Fig 1. Two pairs of electrodes were inserted through the specimen's small side, thus creating a measuring depth of 10 ± 1 mm and 3 ± 1 mm. The embedded length of the electrode was about 30-40 mm; the exact length depended on where the desired measuring point was located. In specimens with cracks going in the direction of the fibers, the electrode length was adapted so as to minimize the distance between the bottom of the crack and the uninsulated tip of the electrode, ie the tip was located just below the crack in question. As a result, the sensor output represents a local measure of MC near the crack in question. Depending on the depth of the crack, it is possible for the electrodes to be in direct contact with water. The distance between the electrodes of each pair was set at 30 mm, according to the sensor default electrode configuration.

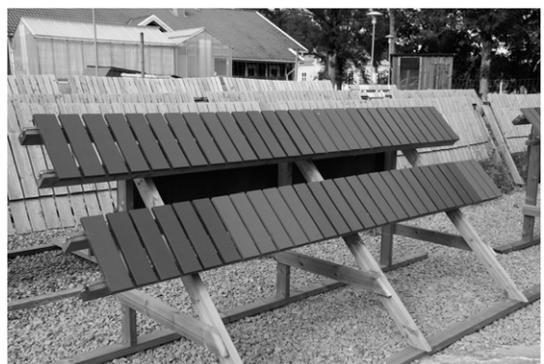
Figure 2. The exposure racks at the test field.

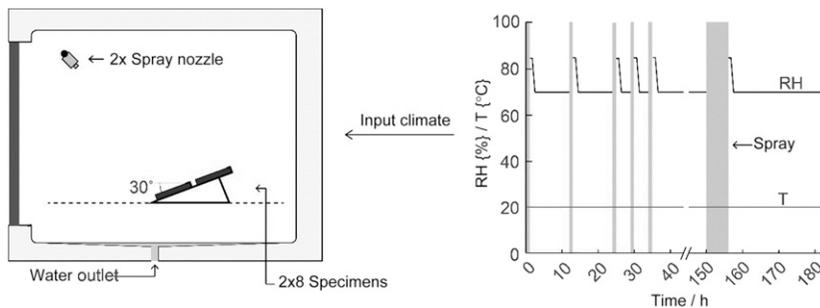
Figure 3. Side view of the climate chamber with a set of specimens organized in a 3×4 grid (left) and the climate sequence that was used serving as input (right).

are shown in Fig 3. Two full-cone spray nozzles were used to simulate rain. The area of each replicate that was exposed to water from the spray nozzles had dimensions of $(190 \pm 2 \times 60 \pm 2)$ mm² (longitudinal \times tangential); the rest of the area was covered with watertight tape. The nozzles gave a uniformly distributed pattern over the entire exposed area. A flow rate of 1.4 L/min was used, which translates to about 84 mm/h, with the exposed area being 1 m². The flow rate was selected so as to maintain a water film on the specimens during the entire spray sequence. The temperature of the water was kept constant at $20 \pm 2^\circ\text{C}$. Each spray period was 1 h long; the periods involved began at times $t = 0, 12, 24, 30,$ and 36 h. After the fifth spray session at 36 h, the panels were left for 114 h before a final spray sequence of 5.5 h was begun. Because of the high moisture load after each spray, the RH increased to full saturation before slowly reducing after

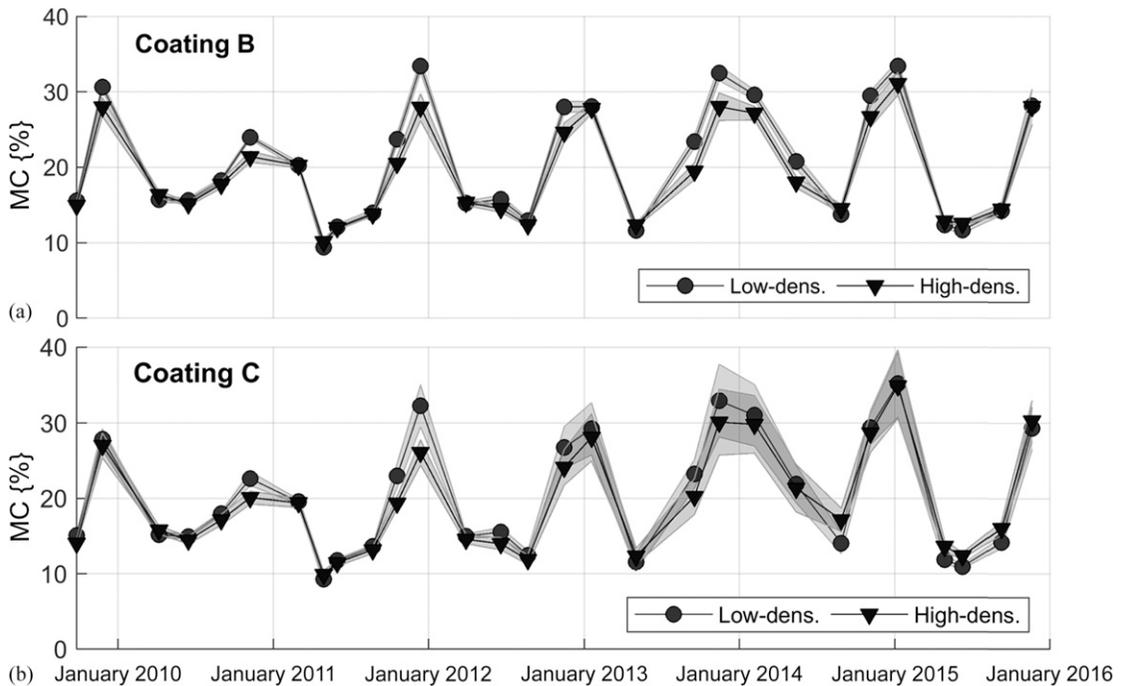
Figure 4. MC variations of high- and low-density samples during Part 1, a 6-yr natural weathering exposure. (a) samples with coating B, an acrylic-based coating. (b) samples with coating C, an alkyd-based coating. The standard deviation of MC with 2σ is presented as shaded areas.

Figure 4 presents the average MC fluctuation of the replicates for each sample; Fig 5 describes the climate during the same period. The MC followed an annual cycle, with peaks during colder months (November-February) and valleys during warmer months. The measured MC ranged from 9 to 33% during the first years, with no pronounced differences between different coating types. The

largest differences between the density groups in MC were recorded at the annual peaks, where low-density samples had higher MC than high-density samples. This feature, of low density being associated with high MC, was equally pronounced for both coating systems during the first 4 yr.

The long-term study revealed an interesting pattern, wherein the initial moisture sorption behavior changed with prolonged weathering exposure. Initially, the MC (Fig 4) for the two types of coatings exhibited similar behaviors, where the low-density samples in each coating group had a slightly higher MC than the high-density ones. This behavior was most pronounced at elevated MC. During the dry-out phase, the density groups converged to similar MC levels. The higher MC of low-density samples resembles

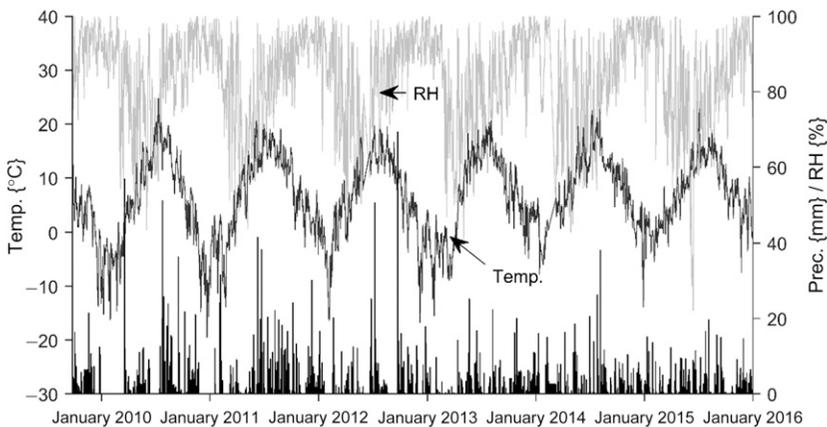
Figure 5. The variation in temperature, RH, and precipitation during exposure period Part 1 in Fig 4.

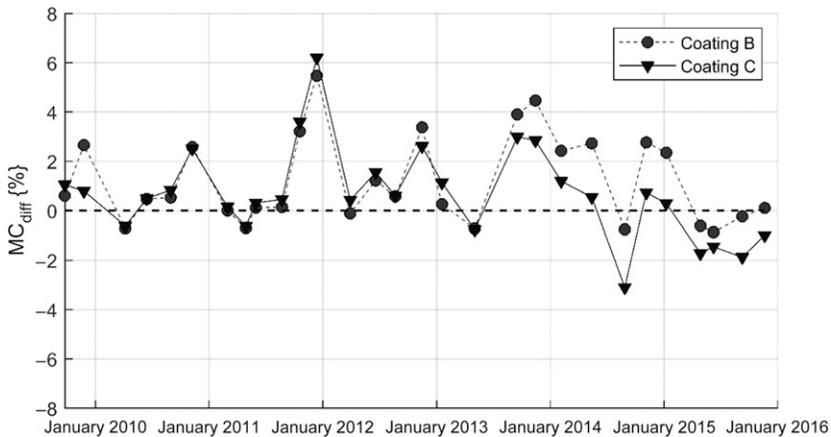
Figure 6. The difference in MC, with the value of low-density sample minus the value of high-density sample (MC_{diff}). Coating B, acrylic-based coating; coating C, alkyd-based coating.

Figure 6 illustrates the difference in MC (MC_{diff}) between the high-density and low-density samples

of the same coating. Positive MC_{diff} signifies that the low-density measured higher MC than the high-density ones. The difference in MC between a low-density and a high-density sample was at most six percent. As seen in Fig 6, MC_{diff} exhibits a regular seasonal variation, in addition to some short periods with negative values, during the first 4 yr. The magnitude and general variation of MC_{diff} were similar in the first year of exposure for both coating types. However, the trend changed around June 2013, when the MC_{diff} values started to diverge between the coating types. The samples coated with coating B, an acrylic resin, continued with similar fluctuations in MC_{diff} values as they had in previous years. The trend was broken with coating C, where MC_{diff} values became lower and even predominantly negative, with a reverse dependency relative to density. During the final 2 yr (2014 and 2015), the samples with coating C measured higher MC for high-density than low-density wood.

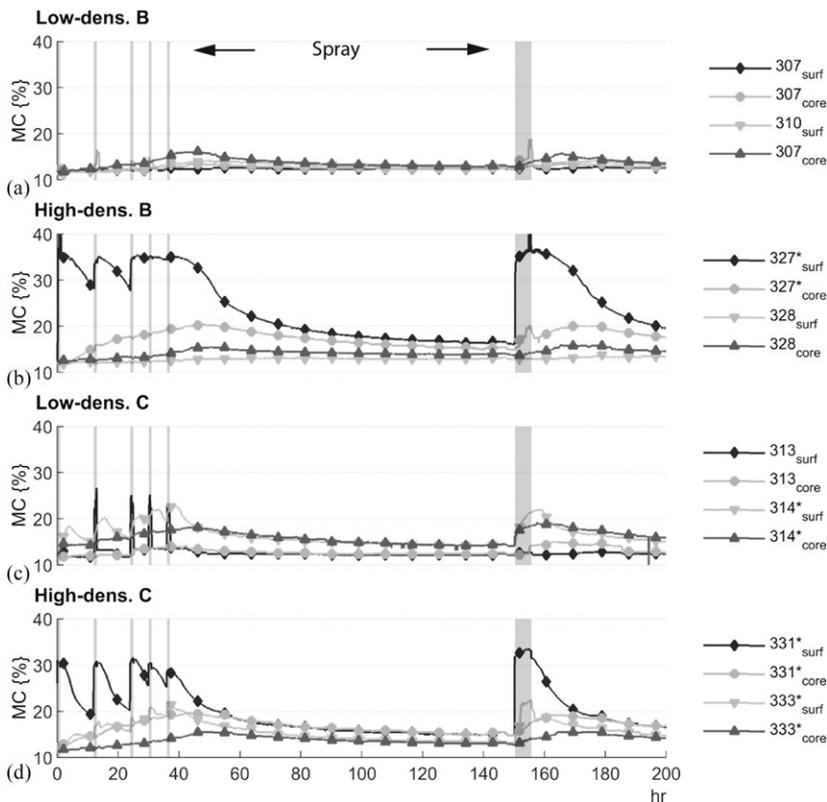
Figure 7. Moisture variations of the individual replicates during the laboratory scale resistance measurements in Part 2. dens, density; B, acrylic-based coating; C, alkyd-based coating. The asterisk indicate replicates with cracks; surf, beneath-surface value; core, center-located value.

Further studies on the MC variation of different types of cracks could be of interest to future work on sorption models of the coated wood. The absolute values of MC in Fig 7 should be seen as indicative of the relationship between the replicates because the amount of water from the spray nozzles are far more than any normal amount of precipitation. See also the similar experimental setup in Niklewski et al (2018b), where previously weathered and newly planed surfaces were examined in a similar way with accelerated water spray. The water exposure per m² from the nozzles was 84 mm/h, whereas the precipitation at the Asa test field was measured to be on average 2 mm/d during the test period.

The MC curves of weathered replicates without cracks in Fig 7 had a surprising moisture gradient after a prolonged period of increased ambient humidity. The MC was slightly higher in the core than beneath the surface. The higher MC (approximately 2%) in the core was beyond any measurement errors and was probably caused by a moisture uptake from the uncoated backside of the replicates. The opposite was seen in the weather-unexposed replicates, with a lower MC in the core than beneath the surface. This peculiarity could possibly be related to water being absorbed from the backside of the sample, either as liquid water through condensation or as water vapor. The surface of weather-exposed wood is less hydrophobic than nonweathered wood (Kishino and Nakano 2004); as such, condensation would be more easily absorbed on the backside of weathered wood surfaces. Some research also suggests that the absorption of vapor could be higher with weathered wood surfaces (Kalnins and Feist 1993). The increased moisture sorption due to weathering could thus explain the higher MC in the core of the weathered replicates as compared with the unexposed ones.
