A METHOD TO CHARACTERIZE BIOLOGICAL DEGRADATION OF MASS TIMBER CONNECTIONS¹

Abstract. Biological durability issues in cross-laminated timber (CLT) have been majorly ignored in North America because of the European origin of the material and careful construction practices in Europe. However, the risks of fungal and insect attacks are increased by the North American climatic conditions and lack of job-site measures to keep the material dry. The methods to evaluate durability in solid timber are inadequate for use in mass timber (MT) for a number of reasons, such as moisture variation and size being critical issues. This study therefore proposes a method, which is suitable to evaluate the strength of MT assemblies that are exposed to fungal degradation. The objective of the study was to explore a controlled method for assessing the effects of wetting and subsequent fungal attack on the behavior of CLT connections. Two different methods were used to create fungal attack on CLT assemblies. Although they were both successful, one was cumbersome, left room for many errors, and was not as efficient as the other. In addition, a standardized method to evaluate and characterize key performan

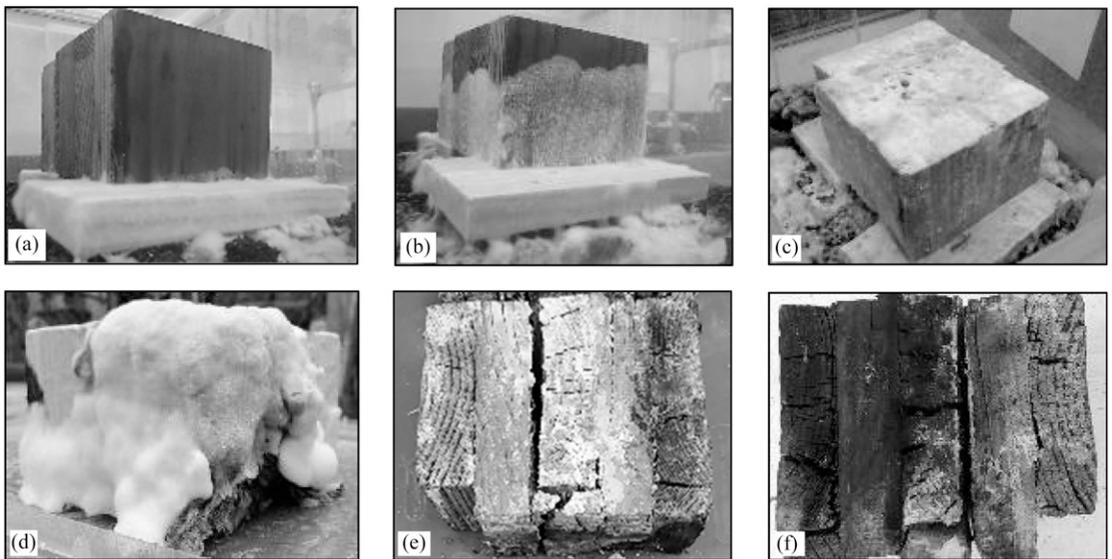
Figure 1. Progression of fungal growth over Douglas-fir cross-laminated timber (CLT) samples exposed to *Rhodonía placenta* for (a) 3 d, (b) 20 d, (c) 61 d, and (d) 264 d after inoculation as well as examples of the bottom of the same sample in direct contact with the test fungus before (e) and after (f) oven drying.

necessarily to mimic natural exposure in a building (Fig 1). This section describes two distinct methods to successfully inoculate the specimen with decay fungi.

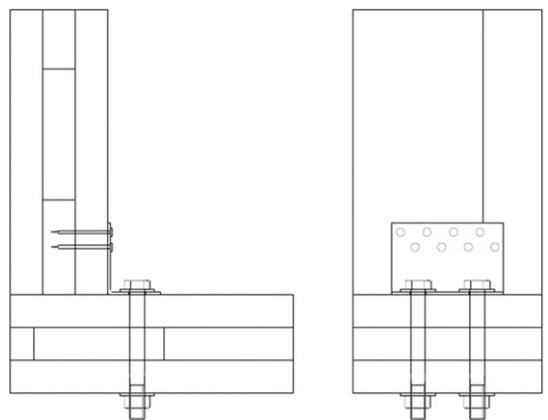
Figure 2. Schematic of the connection test specimen.

The connection assemblies in the first method were three-ply Douglas-fir (*Pseudotsuga menziesii* var. *menziesii*) ANSI PRG320 V1 CLT (104-mm-thick, 200-mm-wide, and 305-mm-long) panels. Two pieces of CLT were joined using a galvanized steel (12-gauge ASTM A653 Grade 33, 227.5 MPa yield strength) L-bracket connection (Fig 2). Two 15.9-mm-diameter A307 Grade A (ASTM 2014b) hex bolts and eight 8-d common smooth shank nails were used to complete the connection. The connection was assembled with the strong axis of the wall piece

oriented vertically, as is common in most CLT shear wall systems. In accordance with the National Design Specification for wood construction, the bolt holes drilled into the bottom piece were oversized by 1.60 mm (1/16th in.) in relation to the bolt diameter (AWC 2018). Three assemblies were prepared: one was a no fungus and no exposure control, the second assembly was inoculated with *Gloeophyllum trabeum* (Pers ex Fr.) Murr. (Isolate # Mad 617), and the third

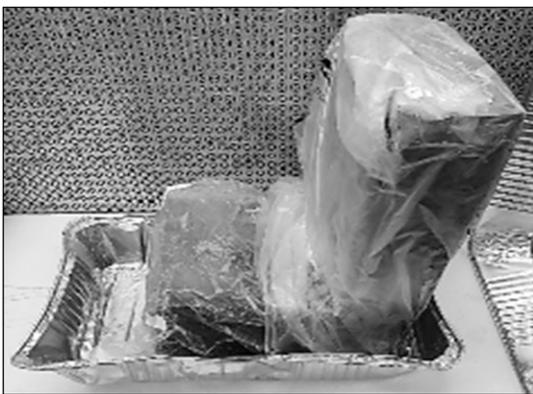
Figure 3. Example of a Douglas-fir connector assembly inoculated with *Gloeophyllum trabeum* showing minimal fungal growth on the outside of the wood.

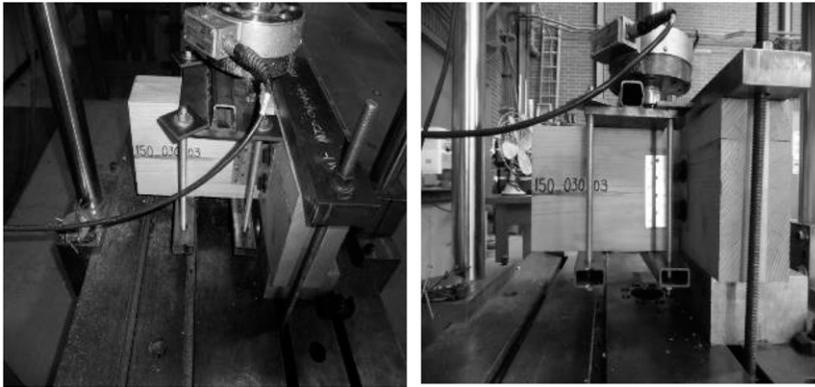
Figure 4. Test setup.

The connections after exposure to degrading fungi were tested on a 178 kN hydraulic universal testing machine (UTM) in a displacement-controlled cyclic loading protocol. Because the UTM and actuator were set up for vertical load application, the specimens were rotated in the test setup to align the lateral direction with the loading axis of the actuator. The test setup is shown in Fig 4. The bottom piece was held in place using a steel bar on top fastened to the testing table with 17-mm-diameter threaded rods. The loading fixture was custom-made for a series of similar testing and is described in greater detail in

Mahdavifar et al (2019) and Mahr et al (2020). The test setup is described in detail in Mahr et al (2020) where the reader is directed for design of the custom fixture. For future research, the design of the custom fixture will however change as per the requirements of accessible UTM. Important things to consider in design of the test setup are that the rotation and translation of the floor plate should be restricted.

For cyclic testing, the actuator head needed to clamp both sides of the specimen wall piece to transmit force in both directions. This was accomplished by using two pieces of steel tubing on the opposite wall side connected to the actuator head with 9.5-mm (3/8 in.) threaded rods (Fig 4). To simulate in situ shear wall conditions for this connection, the rotations of the wall piece were not controlled, leaving the bracket connection itself to resist these rotations.

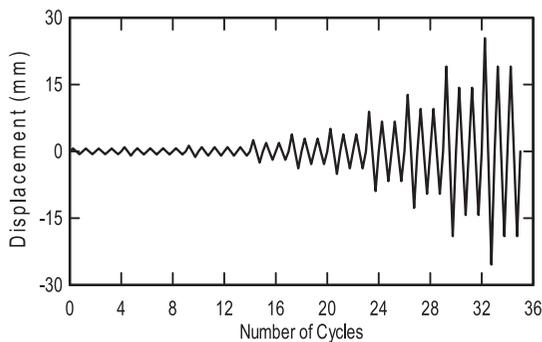
Figure 5. CUREE loading protocol.

The cyclic loading was performed according to an abbreviated basic loading history CUREE protocol, developed by Krawinkler et al (2001), with two additional primary cycles beyond the reference deformation (Δ) of 1.5Δ and 2.0Δ , respectively (Fig 5). These additional primary cycles were used to ensure specimen failure. The CUREE reference deformation of 12.7 mm was determined by Mahr et al (2020) according to methods identified in Krawinkler et al (2001) by performing monotonic tests. The loading rate used was 7.2 s per/cycle for 35 cycles, yielding a total loading protocol duration of 4 min and 12 s. The maximum displacement rate was 11.4 mm/s in the final primary cycle. Data collected included actuator load and actuator head displacement,

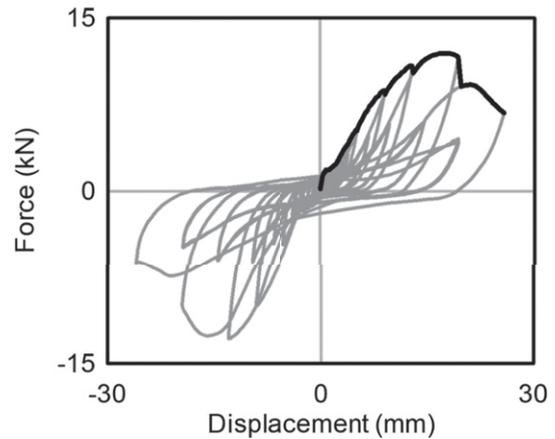
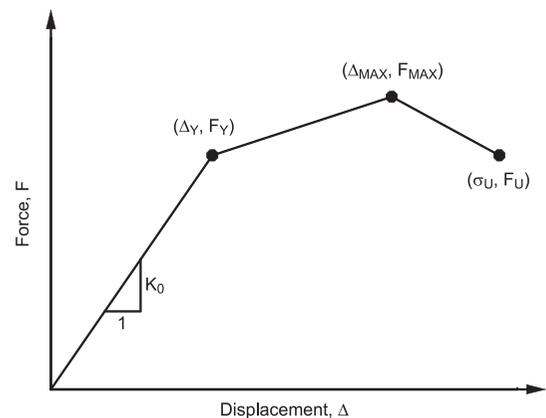
Figure 6. ASCE 41-17 trilinear idealization process.

The primary cyclic force–displacement data from the testing generated hysteresis curves for each specimen (Fig 6[a]). The backbone curve of the hysteresis curves was developed for each specimen by plotting the maximum first force recorded at each displacement from the hysteresis data, effectively only plotting force from the primary cycles of the CUREE displacement protocol. The backbone curves (Fig 6[a], bold line) were then used to define parameters and/or equations that approximate the force–displacement relationship using a trilinear model as outlined in ASCE 41-17 (Fig 6[b]).

tests. The curve type that is appropriate for this kind of research is the Type 2 curve as outlined in ASCE 41-17. The Type 2 curve is a composite curve of three linear segments: elastic, post-yield plastic, and post-peak plastic. ASCE 41-17 does not specify a procedure for determining where each of these segments begin and end, leaving it to the discretion of the user. For our purposes, we attempt to define a protocol that has given consistent results over the last few years. The parameters are listed in Table 2 along with their description and protocol used to calculate them. The first line or the initial elastic segment ends at the yield point and has a slope, K_0 . The yield point at the end of the elastic segment is defined by the yield strength, F_Y , and yield displacement, Δ_Y . The yield strength was determined using the 5% offset method outlined in ASTM D 5764 (2018). The 5% offset method defines the yield strength as the point at which the backbone curve is intersected by a line with a slope equal to the initial stiffness (K_0) and which is offset to a displacement of 5% of the fastener's root diameter. The initial stiffness (K_0) was determined by performing a regression analysis on a representative linear portion in the elastic region of the backbone curve generally between 0.1 and 0.4 of F_{\max} . The next line on the composite curve is the post-yield plastic segment beginning at the yield point and ending at the peak of the backbone curve. The parameters associated with the peak are peak strength, F_{\max} , and corresponding displacement, Δ_{\max} . The load–deflection coordinate for the peak was taken directly from the backbone

curve. The final line of the composite curve is the post-peak plastic segment beginning at the peak and ending at the failure point defined by the failure load, F_U , and ultimate displacement, Δ_U . The failure load and ultimate displacement were taken from the last point on the backbone curve with a load greater than or equal to 80% of the peak load. The ASCE 41-17 idealization process is shown in Fig 6.

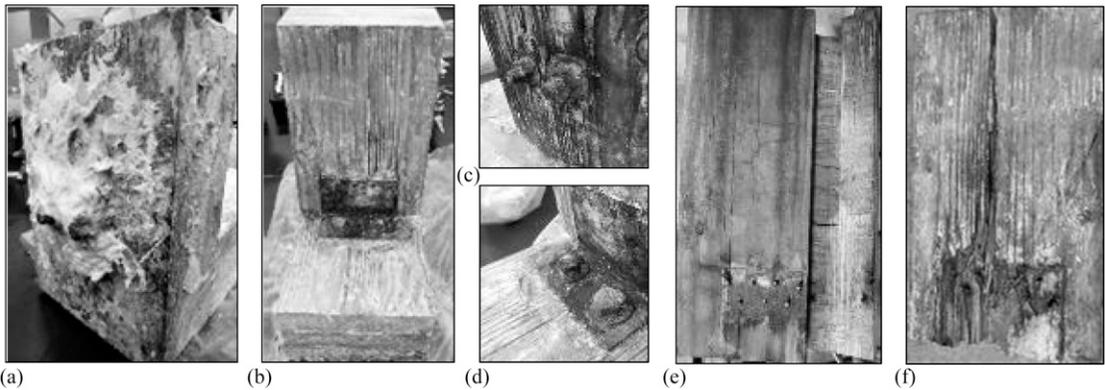
Figure 7. CLT assembly 425 d (14 mo) following exposure to *Rhodonia placenta* using the autoclave bag method: (a) CLT surface with fungal mycelium; (b) fungal mycelium removed; (c and d) steel connection with corrosion; (e and f) connection zones following strength testing.

At the end of the 425-d period of exposure, the samples showed varying changes in physical properties. These included general physical alterations such as colored stains and patches, exfoliation, and pitting stated by Gaylarde et al (2003). There were differences in the physical changes which were observed in the two different fungi species. Whereas brown patches were noticed on the surface of the assembly with *G. trabeum*, the assembly infested by *R. placenta* showed white patches all over. Figure 7 shows the assembly at different stages of exposure and testing. The blocks also showed a variation in the weight changes over the period of exposure as reported in Table 3. The sample exposed to *G. trabeum* weighed 8.52 kg at testing. This was an increase of 2.15% from the original dry weight of the block before it was exposed to the fungi. *R. placenta* however weighed 7.41 kg at the time of test which equates to a 7.72% weight loss. The samples were tested at EMC between 12% and

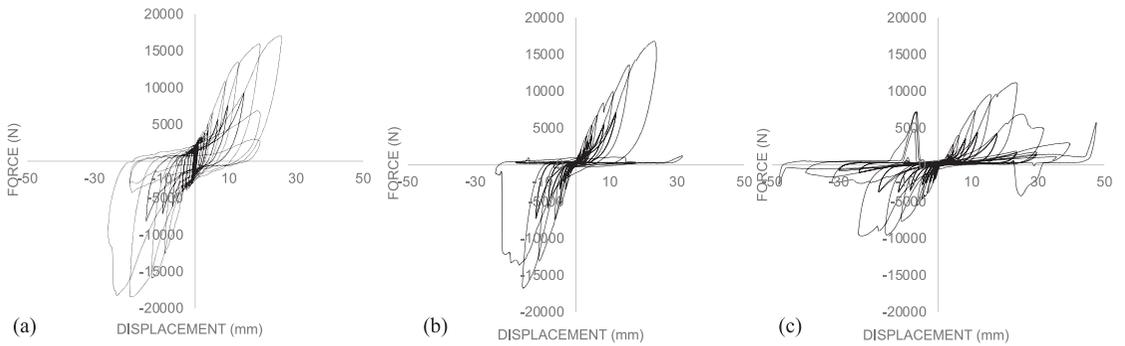
Figure 8. Hysteresis curve: (a) control, (b) *Gloeophyllum trabeum*, (c) *Rhodonia Placenta*.

The failure of the connections could be characterized in two ways. As the load was applied, the nail pushed into the wood and the wood fibers gradually broke and gave way. As a result, the nails either pulled out or yielded. The maximum force at which the connections failed varied in the different specimens. A comparison of the backbones of the hysteresis curve from the three specimens (Fig 8) describes the trend. A substantial reduction in capacity, 35% in the tension side and 48% in the compression side, for the specimen infested with *R. placenta* (Fig 8) was observed when compared with the control specimen. In addition, there was a difference in the critical failure mode in each specimen type. Whereas the failure of the wood fibers seems to

occur first in the assembly exposed to *R. placenta*, the fibers in the assembly with *G. trabeum* and the control failed late into the test. In the control sample particularly, the authors believe that the cellulose and hemicellulose components of the wooden block were intact, and therefore, the wood fibers possessed adequate strength to resist the cyclic load before ultimately failing.

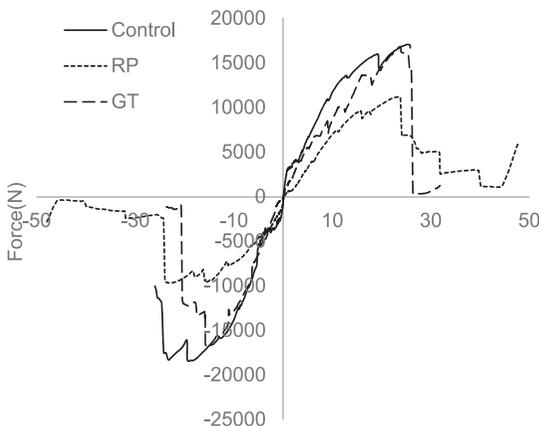
Figure 9. Backbone of the three specimens as obtained from the hysteresis profile.

The average backbone curve of the three specimens was analyzed to characterize the connection strength (Fig 9). A comparison of the three specimens showed a reduction in both tensile and compressive strength as the level of fungal degradation increased. The initial stiffness K_0 calculated using hysteresis backbone generated from the cyclic test protocol was also compared. An initial stiffness of 1056 N/mm was observed in the control specimen. The assembly cultured with *G. trabeum* had an initial stiffness of 1010 N/mm, whereas that exposed to *R. placenta* had an initial stiffness of 788 N/mm.

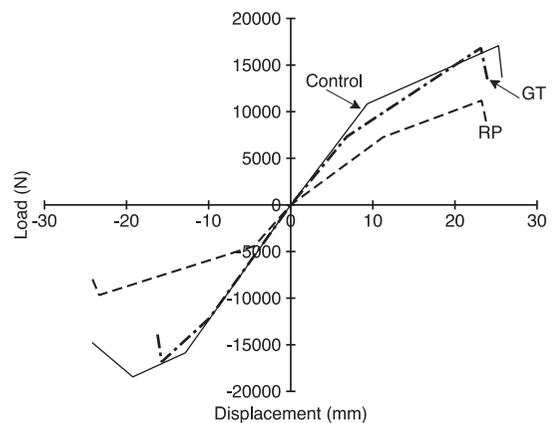
Figure 10. Trilinear idealization as per ASCE 41-17 for the connection performance.

In addition, the ASCE 41-17 trilinear curve (Fig 10) was developed from the backbone to describe the force–displacement behavior of the connections in the three samples. All the parameters calculated from backbone and the trilinear curves are listed in Table 4. The tensile yield load of the three samples was 10,849N, 7329N, and 7268N respectively (Table 4). The assemblies exposed to *R. placenta* had the lowest yield values and the control being the highest. The maximum load in the three samples was 17,081N, 16,832N, and 11,198N. Again, the control specimen was highest and *R. placenta* infested blocks being the lowest.

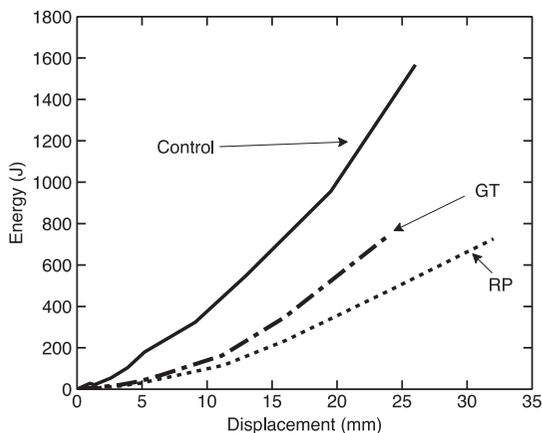
Figure 11. Cumulative energy dissipated with respect to displacement.

The cumulative energy dissipated before the connection failure was computed and is shown in Fig 11. The energy dissipated substantially decreased for *R. placenta* and *G. trabeum*

assemblies as shown in Fig 11. Fungal degradation affects the static-tested energy properties, and therefore, the effect of fungal degradation becomes more apparent with regard to the energy dissipated. Although *G. trabeum* assembly did not show much degradation in peak load, the energy dissipated for the same displacement was lower than the control. Similarly, for *R. placenta* assembly, the energy dissipated was substantially lower than that for the control or *G. trabeum* assembly. This closely aligns with Kent et al (2005) that energy dissipation reduces as degradation increases.
