On site moisture protection: An unnoticed but essential basis for sustainable timber construction

Abstract: Timber construction is gaining popularity in Germany due to its sustainability, versatility, and aesthetic appeal, but, as a biological material, it can develop issues when exposed to moisture. Wood-destroying fungi can significantly reduce durability and structural integrity. Adequate moisture protection during construction is crucial for the longevity and performance of timber structures. This paper examines moisture protection practices on German construction sites and emphasizes the importance of proper on-site moisture management for sustainable timber construction. Visits to sites using timber construction revealed the status of moisture mitigation practices in conjunction with timber construction in Germany. A mixed-methods approach included photo documentation and protocol completion, yielding data for analysis to understand the depth and effectiveness of moisture protection strategies. The findings reveal a gap between problem awareness in the scientific community and practical handling on construction sites. Many sites exhibited disorganized structures and deficien

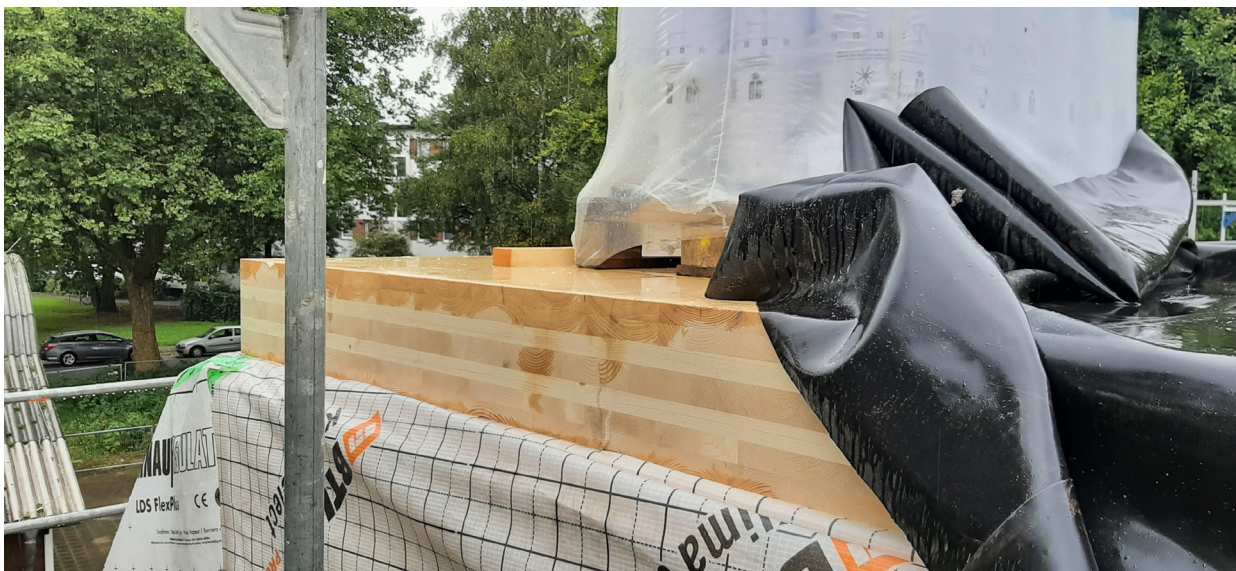
Figure 3. Storage of construction materials for the roof prevented the implementation of temporary weather protection measures (author photograph).

and after transportation, including placement, elevation, and covering of materials to protect them from direct exposure to moisture. In addition, attention was paid to whether secondary materials, i.e., materials that were to be laid in a further work step, could hinder further protective measures due to their placement. For example, a pallet of bitumen sheets was placed on the roof without temporary weather protection underneath (Figure 3). That made it considerably more difficult for the craftsmen to carry out the protective measures before the roofer arrived. No crane was available

at the later stages, so part of the roof stayed exposed to rain, which led to increased moisture levels in the connection joints of the ceiling components.

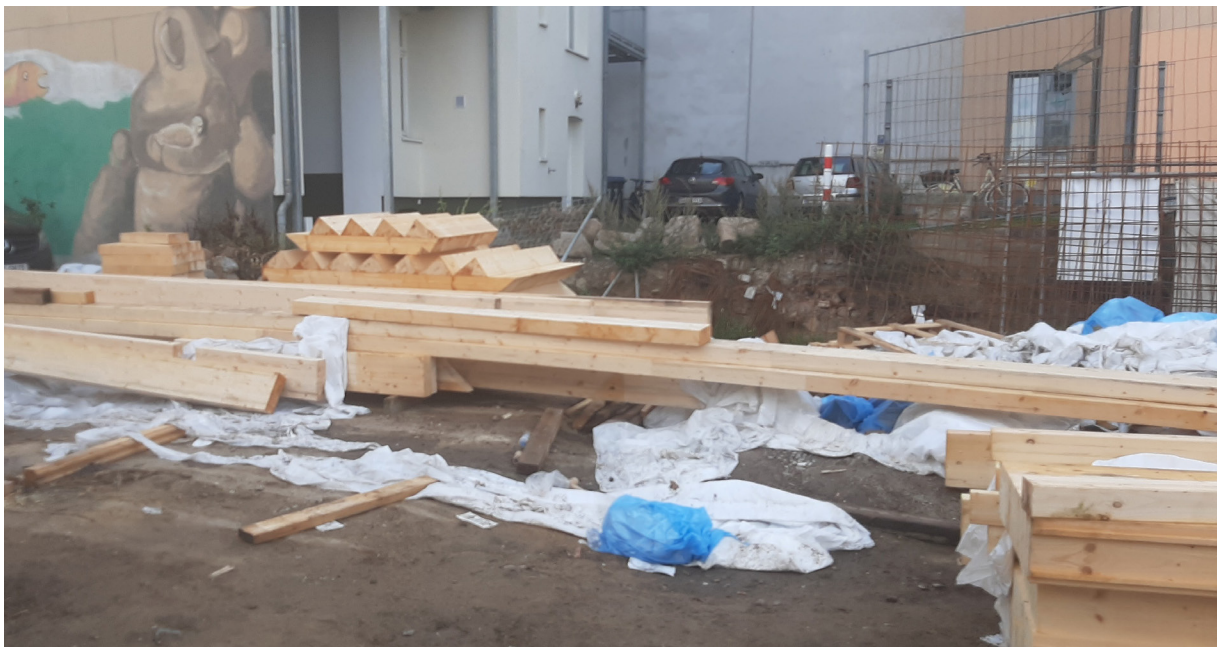
Figure 4. Disorganized construction site, inappropriate storing of mass timber elements (author photograph).

around the site, with emphasis on practices that minimized surface wetting or damage. A typical question was whether or not the components were temporarily stored on the construction site or whether they were installed directly after shipment. Poorly planned or executed storage of construction components not only leads to a loss of quality during rainfall events, but also causes the entire construction site to become disorganized and cluttered (Figure 4). This can result in delays and errors.

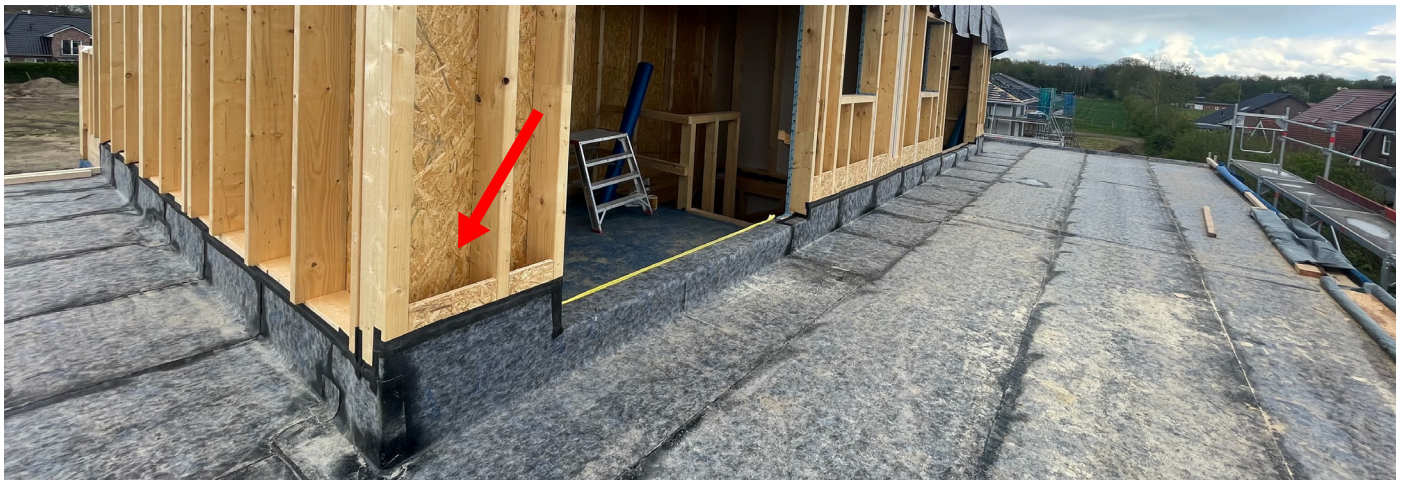
Figure 7. Incomplete protection with possible entrapment of moisture (author photograph).

struction. Particularly critical in this case is the formation of troughs (red arrow) on one side of the structure to enable the waterproofing of the flat roof at the required height. Rainwater (during construction) not only drains poorly there but can also easily accumulate, while at the same time the moisture content is almost impossible to monitor.

Two-thirds (66.67%, full concept + gaps in concept) of cases were found to have concepts in place, yet more than half of these concepts were incomplete by missing important components. This indicated that while moisture protection strategies were present in many cases, their implementation was often insufficient or incomplete. Further research and efforts, such as enhanced education, are necessary to ensure that future efforts are fully realized and effectively integrated into construction practices. Figure 7 shows a three-story semi-detached house with a low level of prefabrication. The concept involves fully covering all horizontal components. While the interior was sealed to prevent moisture from entering the cavities, the exterior was left open. This construction method requires a schedule that allows for drying measures before insulation is installed. Drying is possible due to the simplicity of the con-
