# IMPACT OF MOUNTAIN PINE BEETLE-ATTACKED LODGEPOLE PINE LOGS ON VENEER PROCESSING

**Abstract.** Pilot plant tests and mill trials were conducted to quantify the impact of using mountain pine beetle (MPB)-attacked lodgepole pine (*Pinus contorta* Dougl.) wood on green veneer processing, and determine if it makes economic sense to sort and process MPB logs separately from normal logs of white SPF (spruce-lodgepole pine-alpine fir) mix for plywood manufacturing. The results demonstrated that log dry-out, improper log conditioning, and veneer peeling contribute to the breakage of veneer ribbon, and in turn, loss of veneer recovery at the green end when processing MPB wood. Compared with the green SPF veneer controls, green MPB veneer has lower moisture content (MC) with smaller variation. The MPB veneer can be clipped narrower with an equivalent of 1% increase in recovery due to less width shrinkage, and be sorted more accurately requiring only two green sorts: heart and light-sap. The MPB veneer can also be dried faster with a reduction in drying time by about 25% for the heart veneer and 35% for the light-sap veneer. However, due to higher volume of narrower random sheets and incre

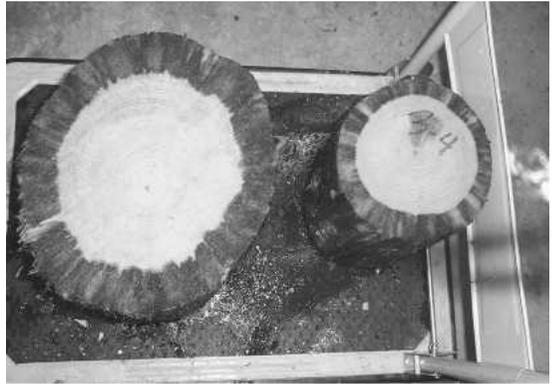
FIGURE 1. The cross-section of MPB logs.

A total of 60 logs (2.4 m long) consisting of 30 logs of typical MPB wood and 30 logs of control SPF were acquired from a cooperating plywood mill in BC. These MPB logs represented a typical log mix from green and red stages of beetle attack. In general, the green stage is defined as within 1 yr, and the red stage 1 – 2 yr after beetle attack. All the tests were performed at the FPInnovations - Forintek's composites pilot plant. To differentiate the logs before conditioning, the MPB logs were marked with numbers, and the control logs marked with letters. For peeling with a 38-cm mini-lathe, 20 logs each were cut into six 33-cm-long blocks, and marked in sequence for MPB and control tests, respectively. Figure 1 shows the cross-section of 33-cm-long MPB blocks. Meanwhile, a 5-cm-

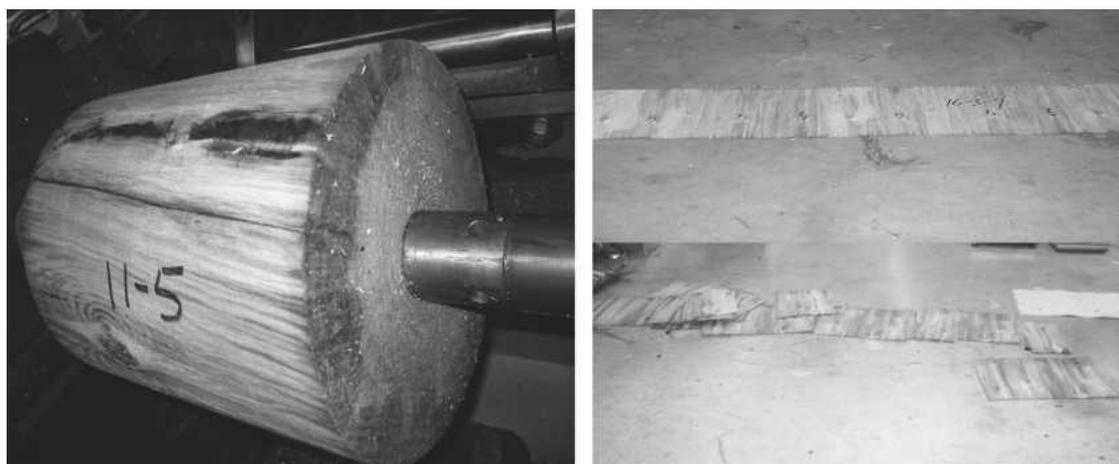
FIGURE 4. Peeling MPB blocks with a pilot plant 38-cm mini-lathe.

**Log conditioning and veneer peeling.** For MPB logs, as shown in Fig 4, cracks appeared in the block after round up. After peeling, the breakage of the sap veneer ribbon occurred regardless of how the blocks were conditioned. In practice, this discontinuity will cause difficulty in handling, sorting, and drying, as well as increase in random-width veneer and a reduction in veneer recovery. If there were no serious cracks, veneer ribbons peeled from MPB blocks would be generally continuous from sap to heart if parameters of conditioning and peeling were appropriate. In contrast, veneer ribbons peeled from control SPF blocks generally did not break.

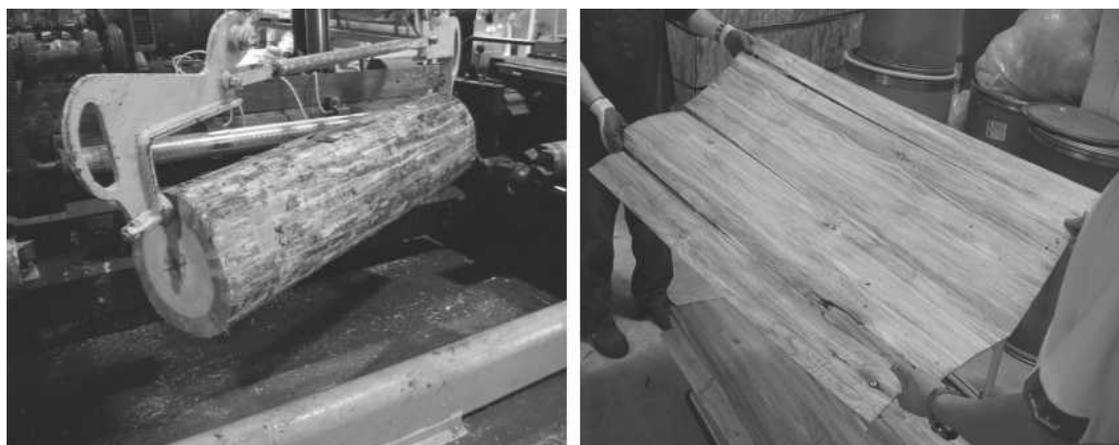
FIGURE 5. Pilot plant scale-up peeling test with a 1.2-m lathe.

To validate the conditioning and peeling parameters obtained from the mini-lathe tests, a scale-up test was performed using a 1.2-m lathe in the pilot plant, as shown in Fig 5. Each of the remaining ten 2.4-m-long logs were cut into two
