# SCANNING ELECTRON MICROSCOPY OF PLYWOOD GLUE LINES<sup>1</sup>

## ABSTRACT

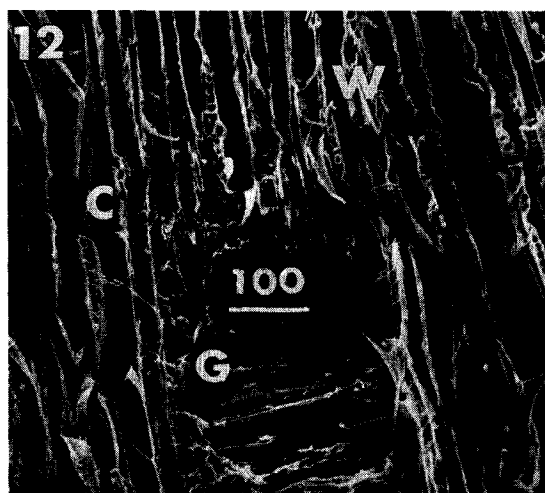
veneer. In Fig. 4, for example, the parallel microfibrillar structure of the S<sub>1</sub> layer is accurately reproduced, while in Fig. 6 a cast of the fiber lumen is produced with the inner surface of the lumen lining accurately replicated. These micrographs suggest that in these areas fairly close contacts have been established between the wood and glue, but probably specific adhesion was not produced because of the inability of the prehardened glue to wet the fiber surface.

FIG. 6. Dried-out glue line in which the spiral thickenings of Douglas-fir tracheids are accurately replicated.
