GROUND-PENETRATING RADAR INVESTIGATION OF SALVAGED TIMBER GIRDERS FROM BRIDGES ALONG ROUTE 66 IN CALIFORNIA¹

Abstract. This study describes assessment of the internal conditions of timber bridge structural members along Route 66 in California. These timber bridges were exposed to desert climate conditions for several decades, which can lead to a variety of deterioration. Overtime, the deterioration may cause loss of structural integrity within the bridges and lead to potentially hazardous conditions for the motoring public. Members from dismantled bridges were brought to the Forest Products laboratory in Madison, WI. Strength-reducing features including decay, splits and cracks, insect attack, and corrosion of metal components were initially identified using visual inspection. Further assessment was then performed using several nondestructive testing technologies including ground-penetrating radar (GPR). GPR was used, among other nondestructive techniques, to identify and locate internal features and defects within the timbers. The tomographic output of the GPR, known as radargrams, revealed deterioration. Based on the information contained within the radargrams, it was possible t

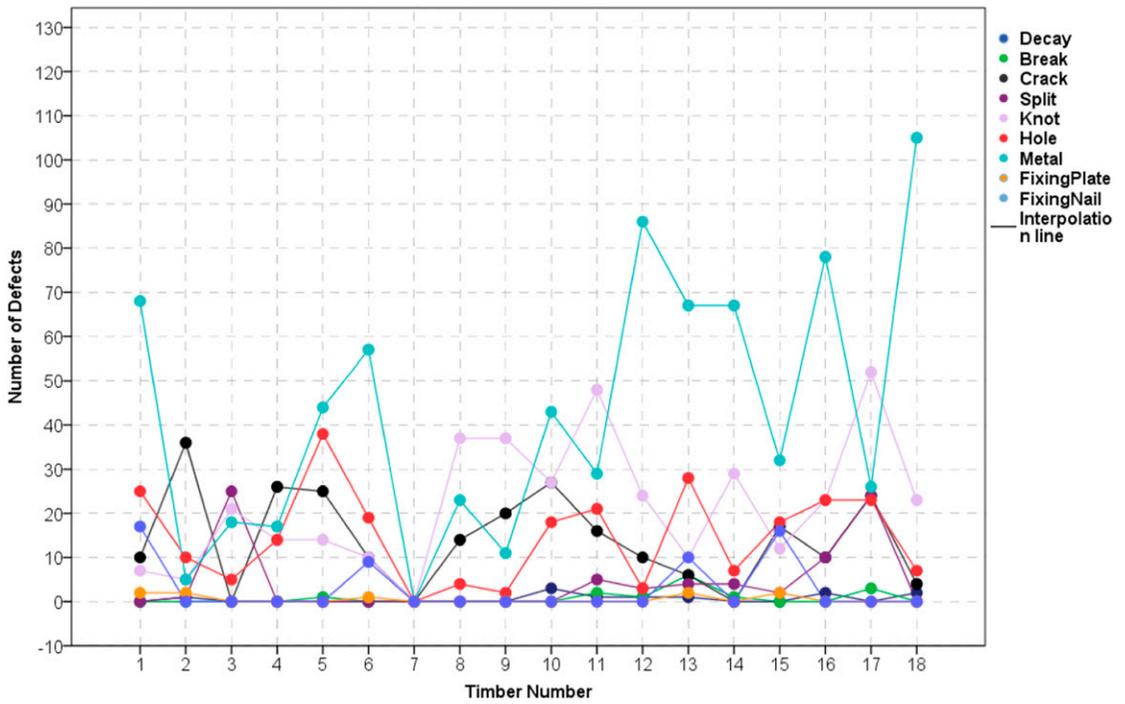
Figure 12. Defect account of 18 timbers.

through visual inspection. The number of characteristics identified through visual inspection of the timbers are given in Table 2 and Fig 12. Characteristics include decay, breaks, cracks, holes, knots, steel bars, steel nails, and fixed plates. Among the 18 timbers, No.7 was unsuitable for the radar test because of the presence of a break through the entire length of the timber. The radargrams revealed some timbers with greater numbers of particular defects. Among them, four timbers (Nos. 5, 9, 17, and 18) had the highest numbers of cracks, knots, holes, and steel nails. The information from the acoustic tests supports the radargram identification of defects within the timbers. Timber No. 5 had the highest number of holes (38) distributed across four sides. In addition, 64 cracks were present. Timber No. 9 had the highest number of cracks (86) and a high number of knots (37). Timber No. 17 had the highest number of knots (52) and a high number of cracks (72). Timber No. 18 had 105 steel nails scattered along the top side. In addition to GPR scans,

acoustic tests, and field visual inspections, photographs recorded the locations of the characteristics along the timbers. There were 25 cracks, 14 knots, 38 holes, and 44 nails or bars visible on the surface of the timbers. Different visible features can be found in the radargrams. The condition of two sides, Faces C and D, on No. 5 is shown in Fig 13. Comparing the defect-mapping data, the photographs, and the GPR images is a valuable way to locate defects. They clearly and accurately reflect the visible condition. The highlighted reflected waves inside the red square (Fig 13[c]) are between 12.7 cm to 177.8 cm and 279.4 cm to 431.8 cm, and correspond to cut sample No. 1 (Fig 13). They can be detected on the three-dimensional image as shown in Fig 13(e).
