# FUNGAL POPULATIONS IN AIR AND MATERIALS IN A FLOOD SIMULATION STUDY

Wood and Fiber Science, 46(4), 2014, pp. 465-479 © 2014 by the Society of Wood Science and Technology

Abstract. Air quality was measured in a building subjected to flooding conditions analogous to that which occurred during Hurricane Katrina. This building was flooded to a depth of 0.61 m above the floor with pond water and maintained at that level for 3 wk. After the floodwater was drained, the building remained closed for an additional 3 wk. Immediately on opening, air samples were obtained and analyzed for fungal spores. Dry and wet material components of the building wall were analyzed for the presence of mold fungi by both culture and molecular techniques. Additional air samples were taken after a 30-da drying period and then after remediation of the building. The air measurements demonstrated the presence of high concentrations of indoor mold spores when the building was initially entered. *Aspergillus/Penicillium* were the dominate air molds. Fiberglass batt insulation supported the greatest concentration of culturable fungi, compared with other wall materials, followed by the paper facings of gypsum boa

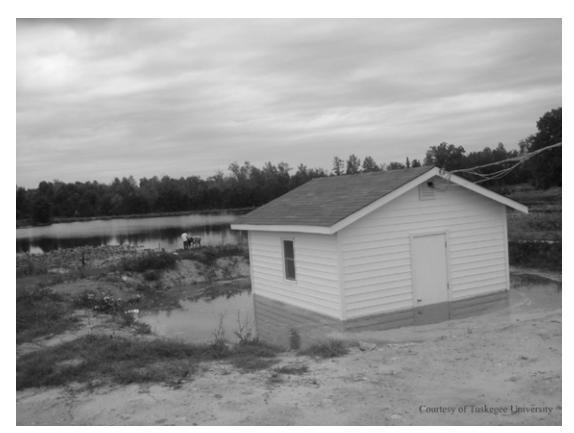
Figure 1. Flood unit built at Tuskegee University at flood stage. Unit is surrounded by 0.91 m of water from a nearby pond (in back of photograph). After 3 wk of flooding, the water was drained and the unit remained closed for an additional 3 wk prior to sampling.

The flood unit was in proximity to a farm pond used by cattle. Near the pond was a pump that transferred the pond water through hosing to the area surrounding the flood unit (Fig 1). The pond water surrounded and entered the flood

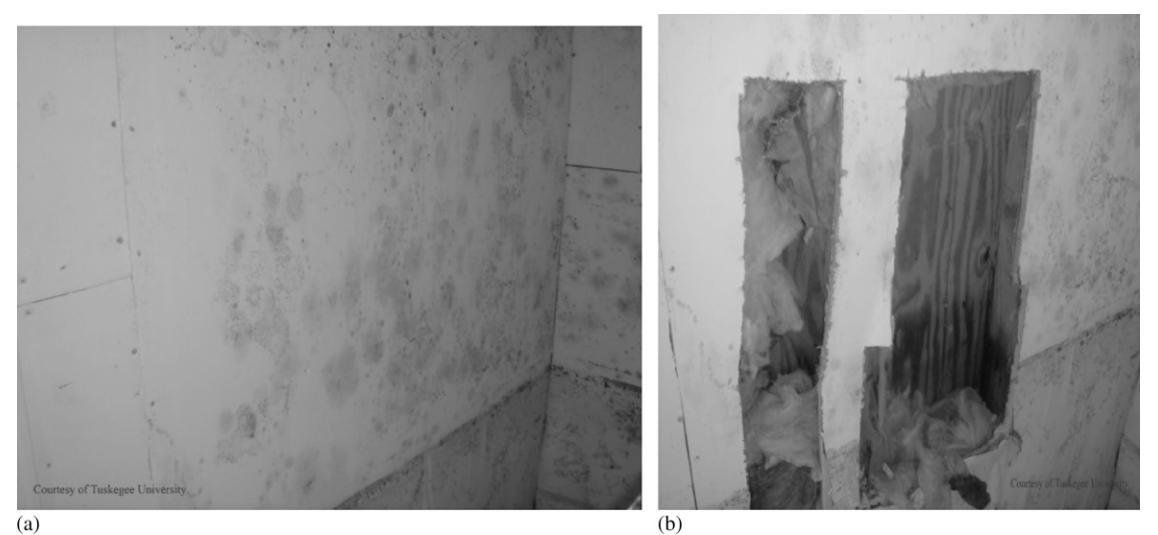
Figure 2. View on re-entry of (a) the south wall from which samples were sent to Mississippi State University for testing of fungi and (b) the sheathing and wood framing inside the south wall after samples were removed for testing.

The interior of the housing unit showed water stains and blistering of the gypsum wallboards below the water line. Severe mold growth was observed above the water line to the ceiling (Fig 2a-b). Figure 2b shows water stains below the water line on the sheathing and wood framing inside the wall. These walls were a possible source for the mold spores in the air of the flood unit at re-entry. The fungi identified from the pond water and wall material samples, segregated by exposure to the flood water, are listed in Table 5. Although 13 different fungi were isolated and identified from the water, the water actually contained very low levels of these fungi. It was necessary to plate 500 µL of pond water straight on the culture media before fungal colonies grew. This made it easy to isolate and subculture these colonies, resulting in a relatively large number that could be identified. Of the 13 different fungi identified from the pond water, five were unique to the water and were not detected on any wall material sampled.
