# FUNGI AND DECAY IN WESTERN REDCEDAR UTILITY POLES<sup>1</sup>

*Theodore C. Scheffer and Barry S. Goodell*

## ABSTRACT

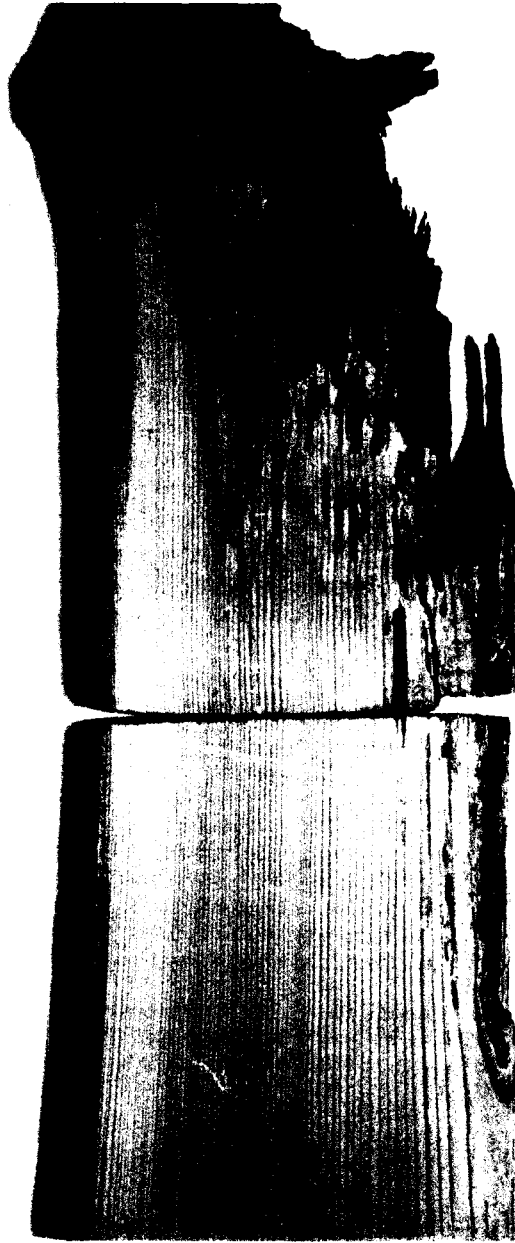
FIG. 2. White rot caused by *Coriolus versicolor* in heartwood of WRC pole. Note pockets in the narrow zone of early decay.

Among our isolates, only *C. versicolor* and *A. lividocoeruleus* came from both heartwood and sapwood. In both cases, the early *C. versicolor* rot produced small pockets (Fig. 2). We are not aware of pocket formation by *C. versicolor* in other than WRC poles.
